Fish Habitat Assessment and Restoration Prescriptions for the Channelized Section on the Mainstem Salmo River from Erie Creek to Hell Roaring Creek

For the
Salmo Watershed Streamkeepers Society
Salmo, B.C.

By
Lisa Heinbuch and Gerry Nellestijn
December 2006

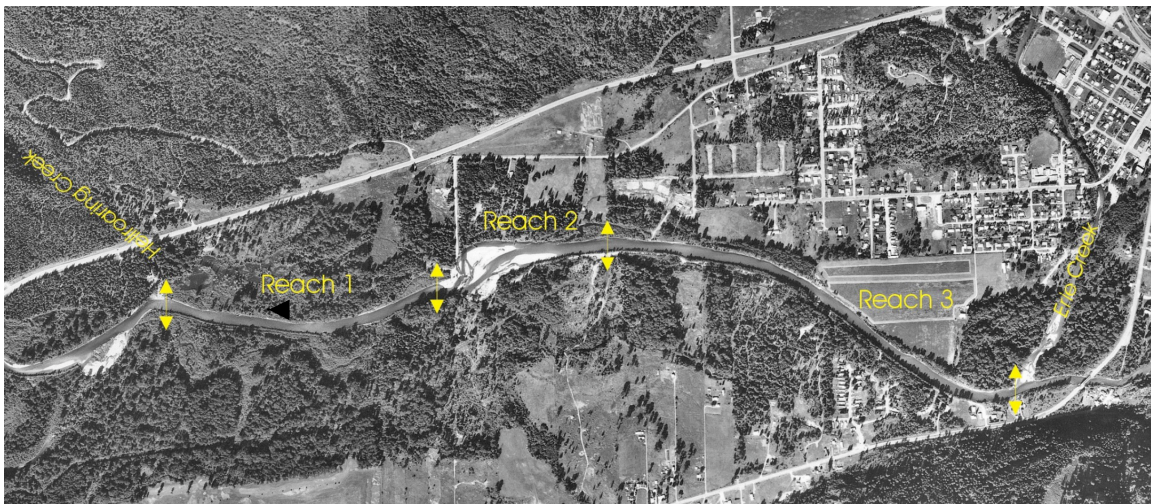
Figure 1. Air-photo (2000) of the Salmo River from the Erie Creek confluence (at the right) to the Hell Roaring Creek confluence (at the left). Flow direction is north to south (right to left) of the air photo.

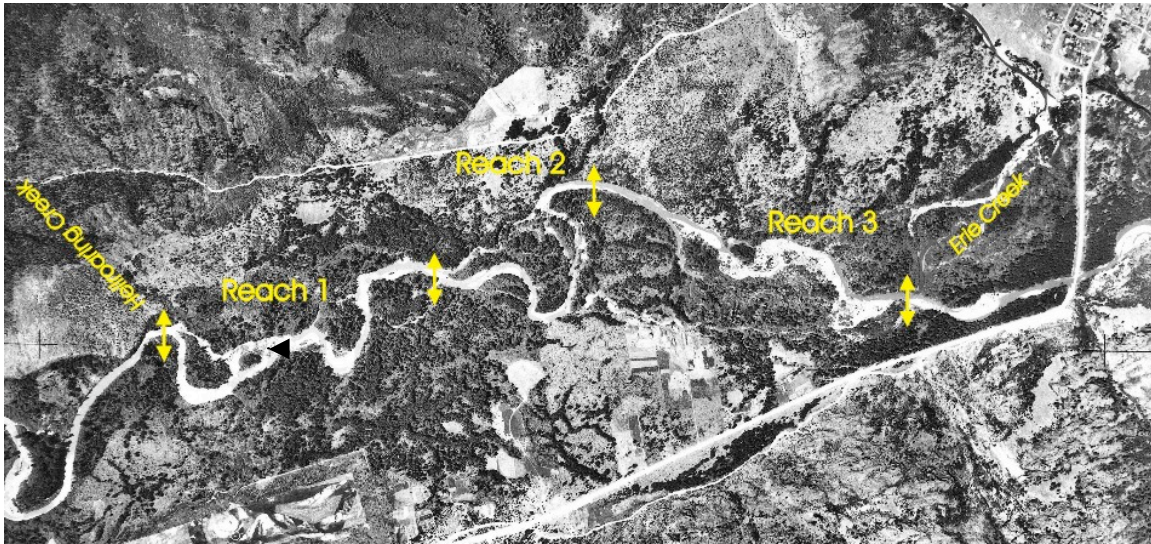
Figure 2. Historic air-photo (1940) of the Salmo River from the Erie Creek confluence to the Hell Roaring Creek confluence illustrating loss of lateral channel migration across floodplain from channelization observed in figure 1.

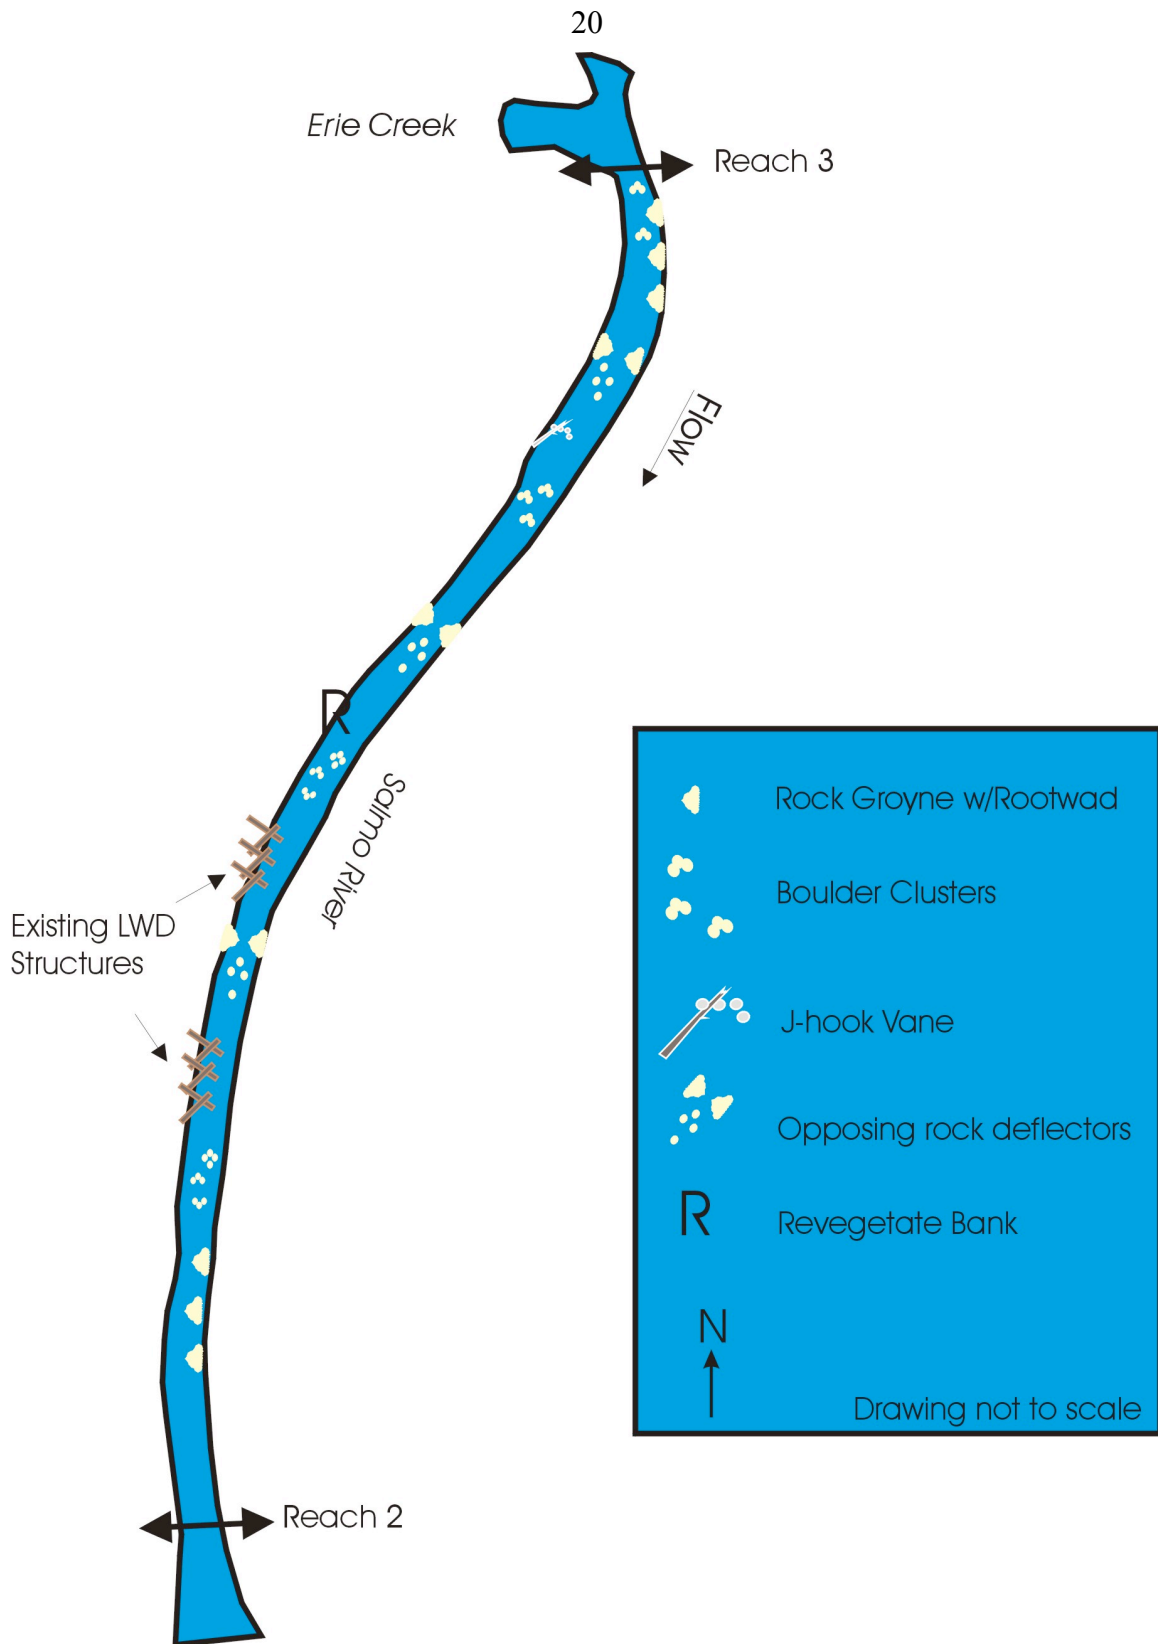
Reach 3 consists of a long, homogenous, highly modified stream reach due to flood control levees and private properties resulting in a loss of riparian vegetation. Structures prescribed in this reach to increase habitat complexity in place of appropriate LWD techniques include: boulder clusters, rock groynes, opposing rock deflectors and a j-hook vane. The schematic layout of these structures is illustrated in figure 3 and conceptual drawings are provided in figures 5, 6, 7, 8. It should be noted that LWD prescriptions in this reach would be beneficial to restoring natural stream ecological functions because porous woody structures provide more habitat for salmonids than rock groynes.

Figure 3. Schematic layout of habitat structures prescribed for the Salmo River Reach 3 from the Erie Creek confluence to the braided section of river in Reach 2. Note that no wood structures were prescribed in this reach due to concerns expressed by local landowners.

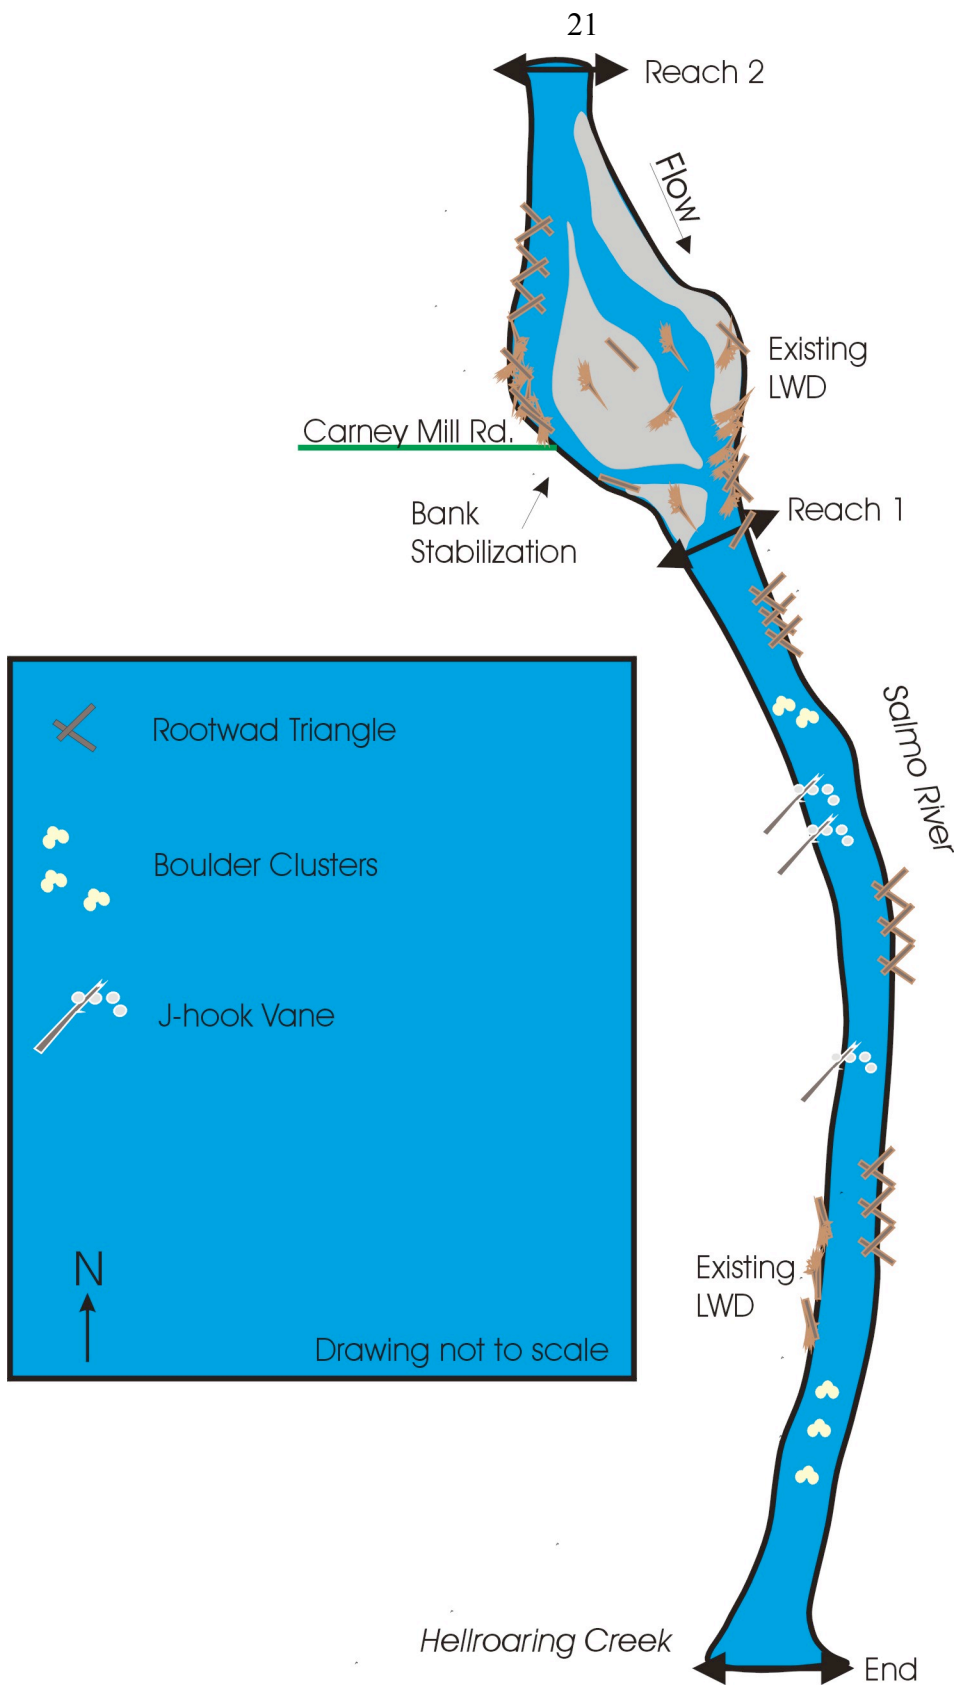
Reach 2 consists of a short braided section of the Salmo River where good fish habitat is present due to natural habitat complexity. Rehabilitation prescriptions in this reach are focused on stabilizing the river access point at the end of Carney Mill Rd. and blocking access to motorized vehicles which have caused increased bank erosion. Bank erosion is also present on the right bank upstream of Carney Mill Rd. and the landowner has expressed interest in structure

installation to reduce the rate of erosion. Three rootwad triangles have been prescribed for the eroding banks in this area but it should be noted that structure installation in this section of river is considered to be 'high risk' due to the dynamic nature of the channel and the potential for installed structures to become dry when the channel shifts. The schematic layout of these structures is illustrated in figure 4.

Figure 4. Schematic layout of habitat structures prescribed for the Salmo River in Reach 2 and Reach 1 to the Hell roaring Creek confluence. Note that few structures were prescribed in Reach 2 due to the dynamic nature of the channel in this area and the good quality existing fish habitat.

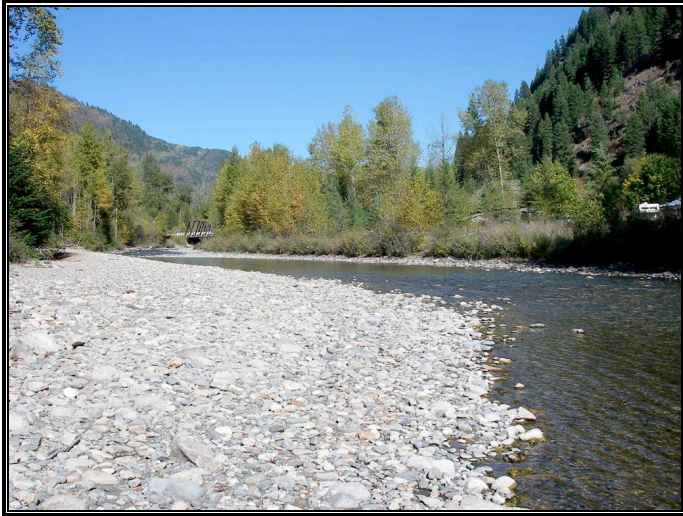
Photo 1. Sta. 1-2 upstream view towards Erie Creek Confluence.

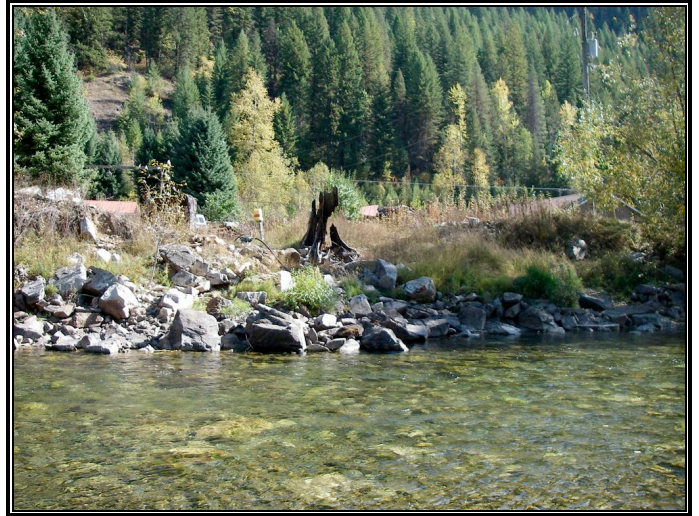
Photo 2. Sta. 2 Rock Groin enhancement 1.

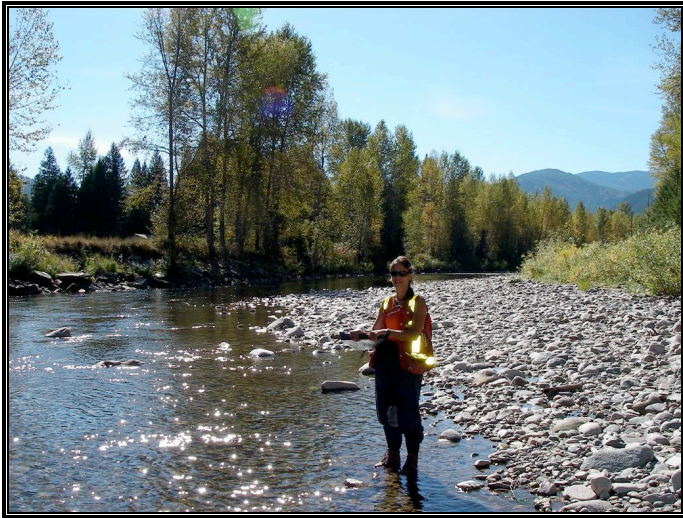
Photo 3. Sta. 3 looking downstream.

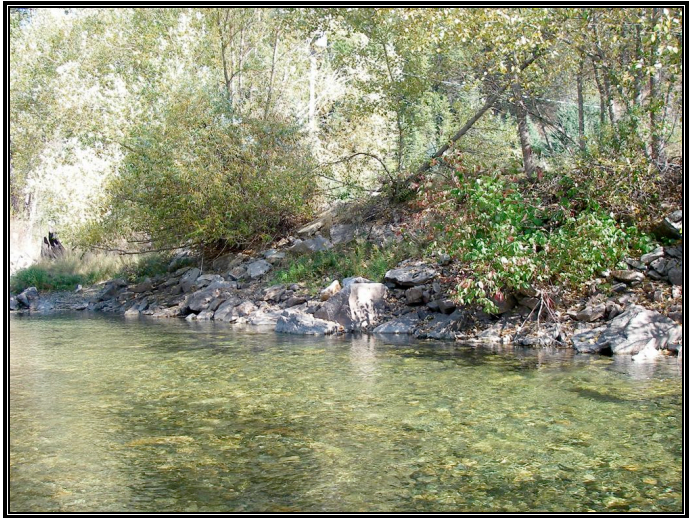
Photo 4. Sta. 3 Rock Groin enhancement 2.

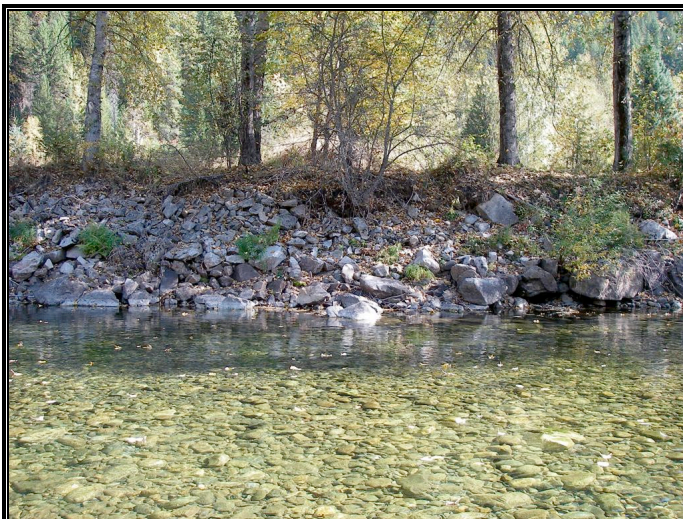
Photo 5. Sta. 3 Rock Groin enhancement 3.

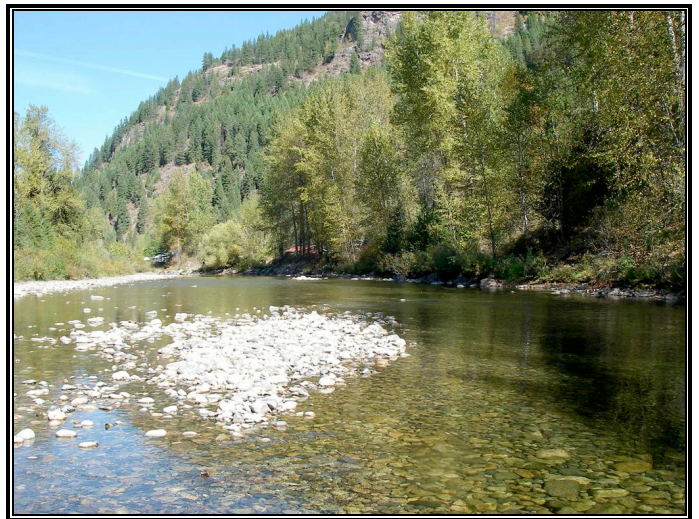
Photo 6. View upstream of proposed Rock Groins.

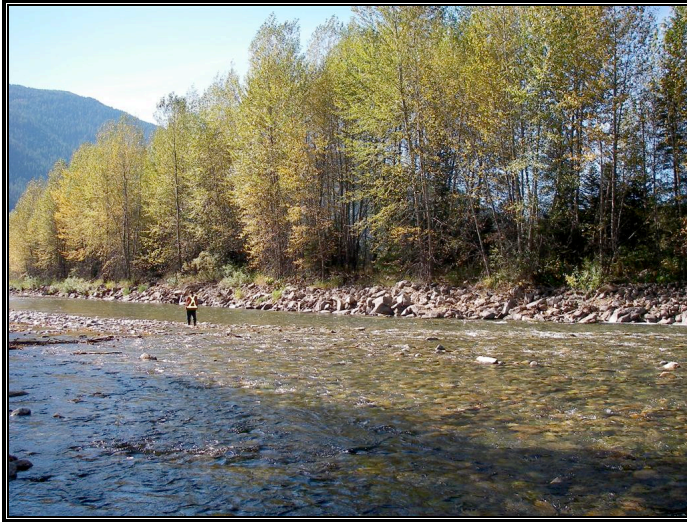
Photo 7. Sta. 3-4 upstream view. Note extensive flood control dykes on bank.

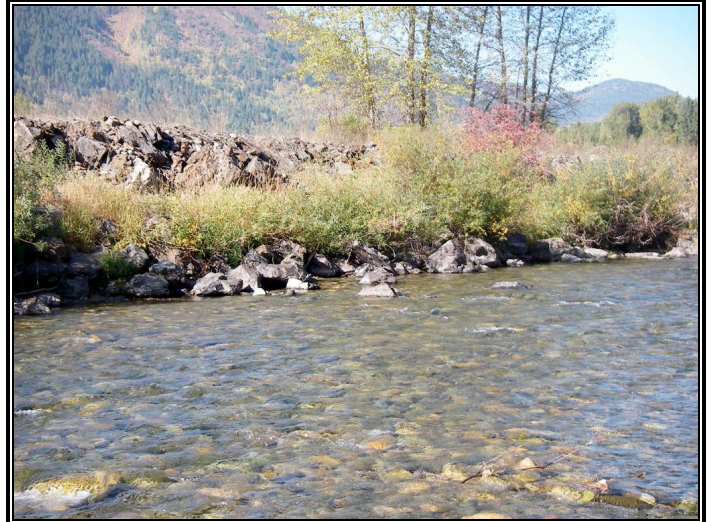
Photo 8. Sta. 6 proposed J-hook Vane.

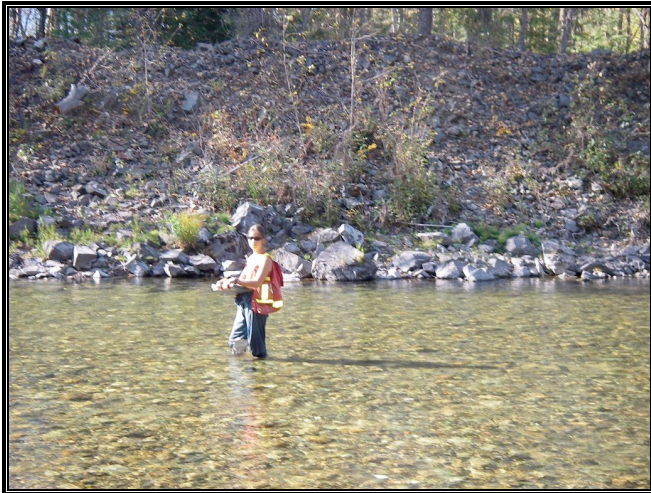
Photo 9. Sta. 11 proposed location of V-weir.

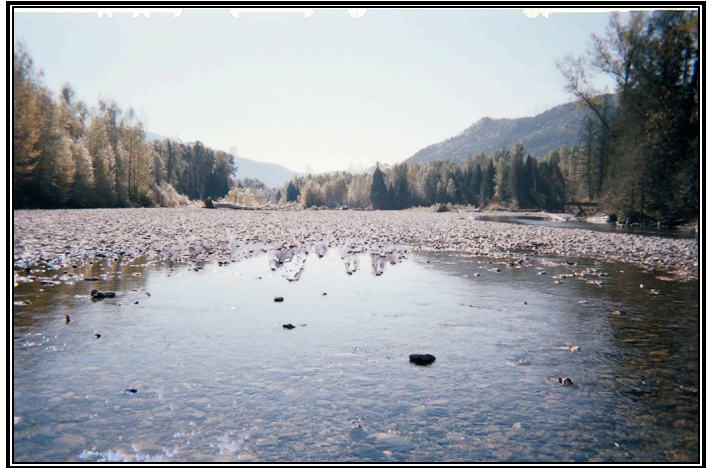
Photo 10. Downstream view of Reach 2.

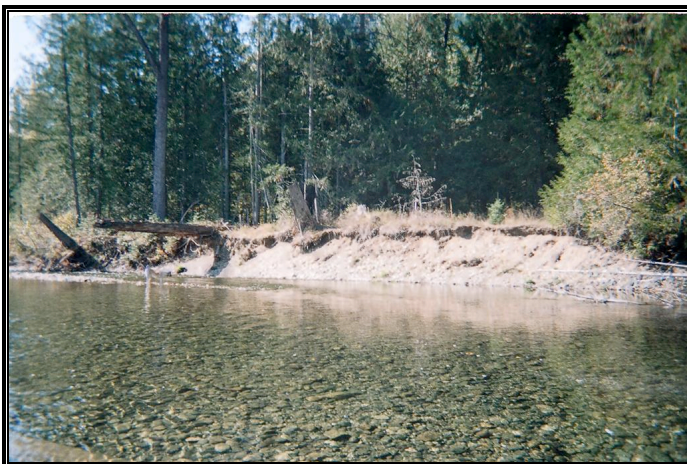
Photo 11. Sta. 15 eroding bank. Proposed Debris Groin.

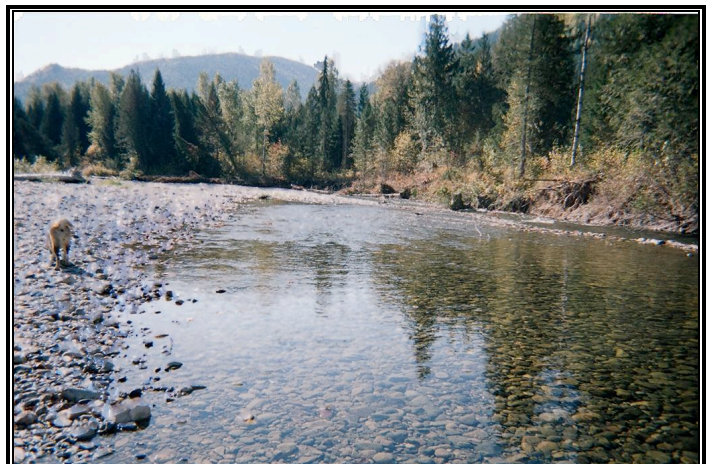
Photo 12. Sta. 16 downstream view eroding bank.

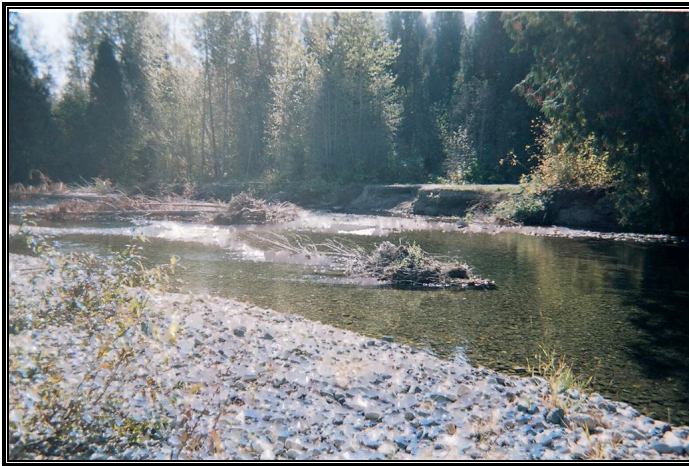
Photo 13. Sta. 20 eroding bank at end of Carney Mill Rd. Proposed bank stabilization.

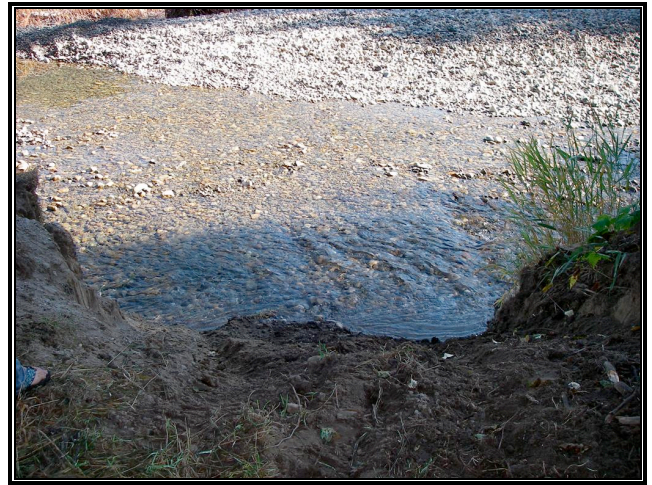
Photo 14. River access end of Carney Mill Rd. eroded by ATV's.

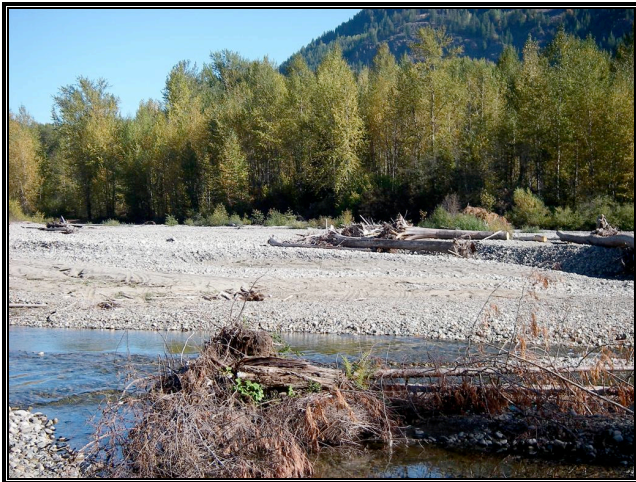
Photo 15. ATV tracks and cut logs on gravel bar in Reach 2.

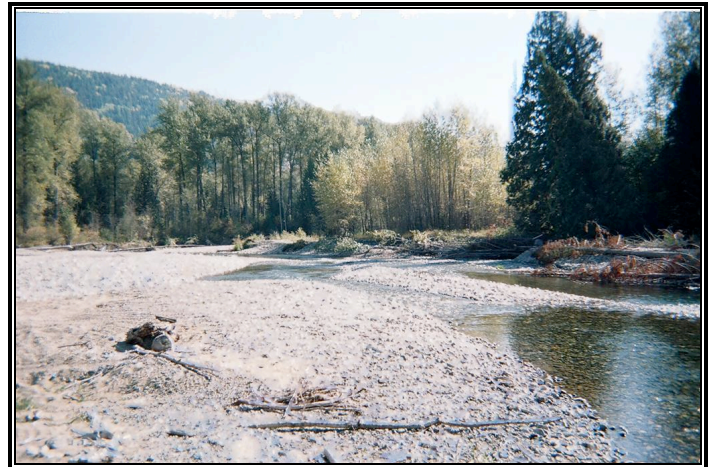
Photo 16. Braided section of channel downstream of Sta. 20.

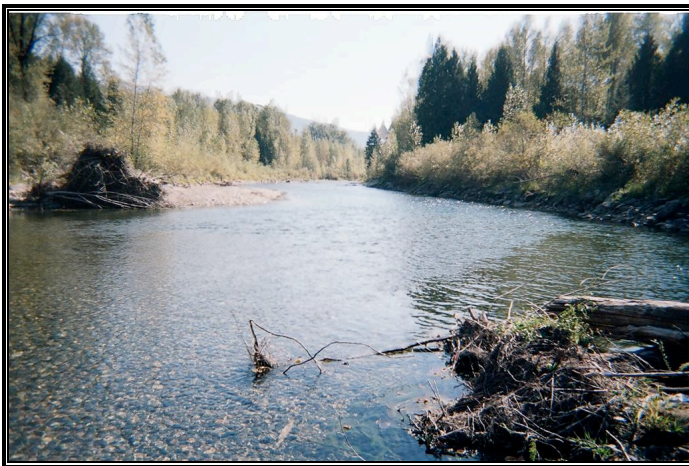
Photo 17. Downstream view Sta. 24-25. Existing riprap on both banks. Prescribed Rootwad triangles and J-hook vane.

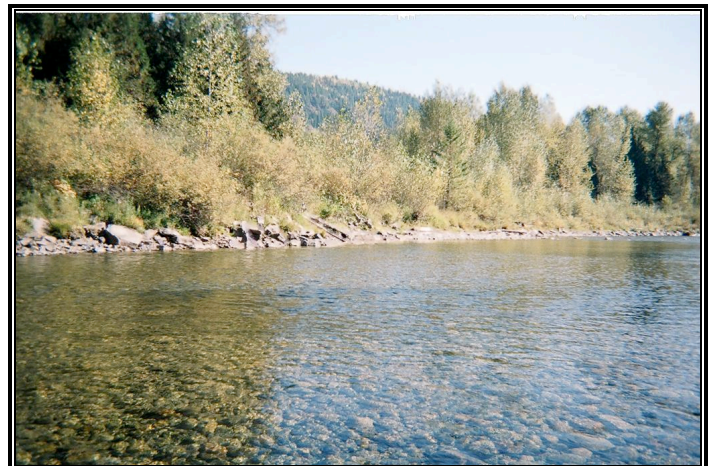
Photo 18. Sta. 24 looking downstream. Proposed Rootwad triangles (3).

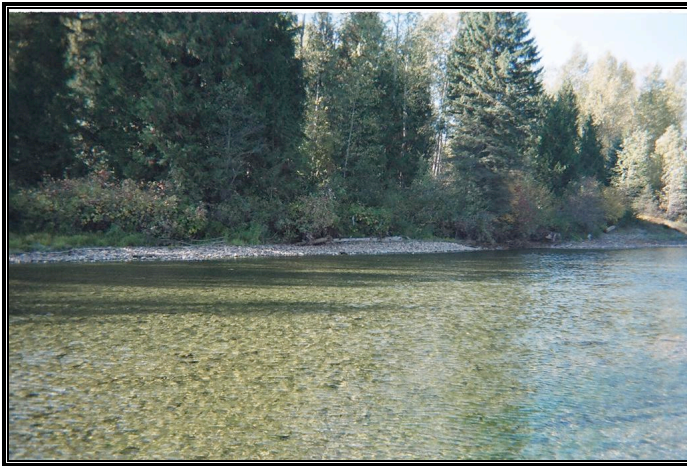
Photo 19. Sta. 26 proposed J-hook vane.

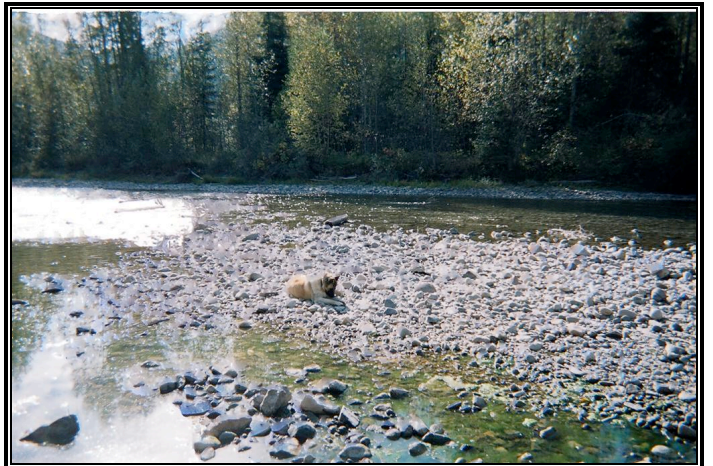
Photo 20. Sta 27 proposed Boulder Clusters in downstream portion of riffle.

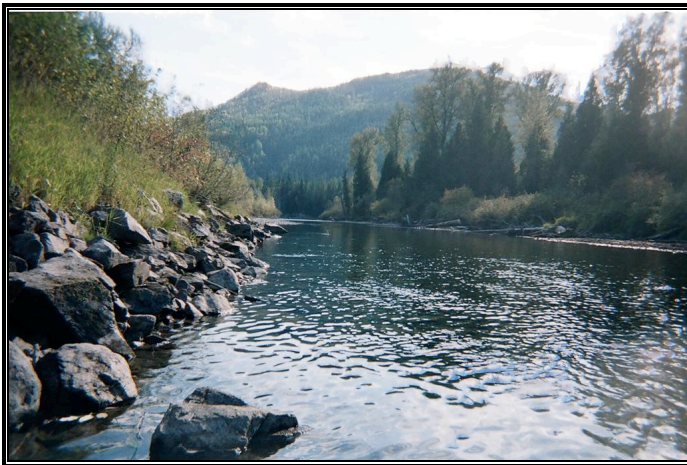
Photo 21. Sta. 28 proposed Rootwad triangles (3) left bank. Natural LWD on right bank.

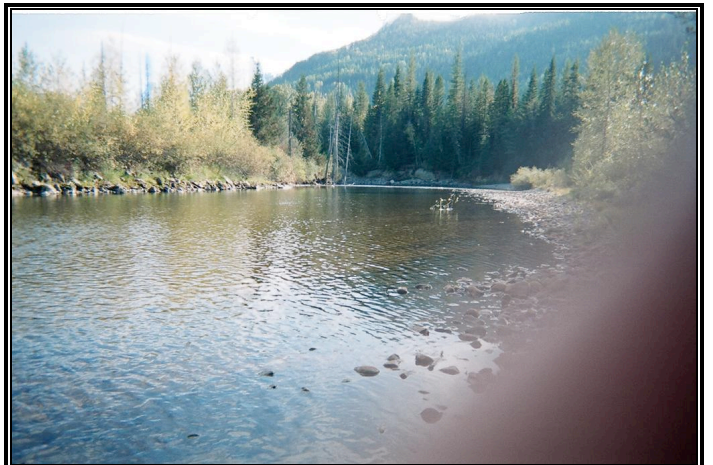
Photo 22. Sta. 30 view downstream toward Hellroaring confluence. No restoration prescriptions due to eroding banks on outside bend of meander downstream.

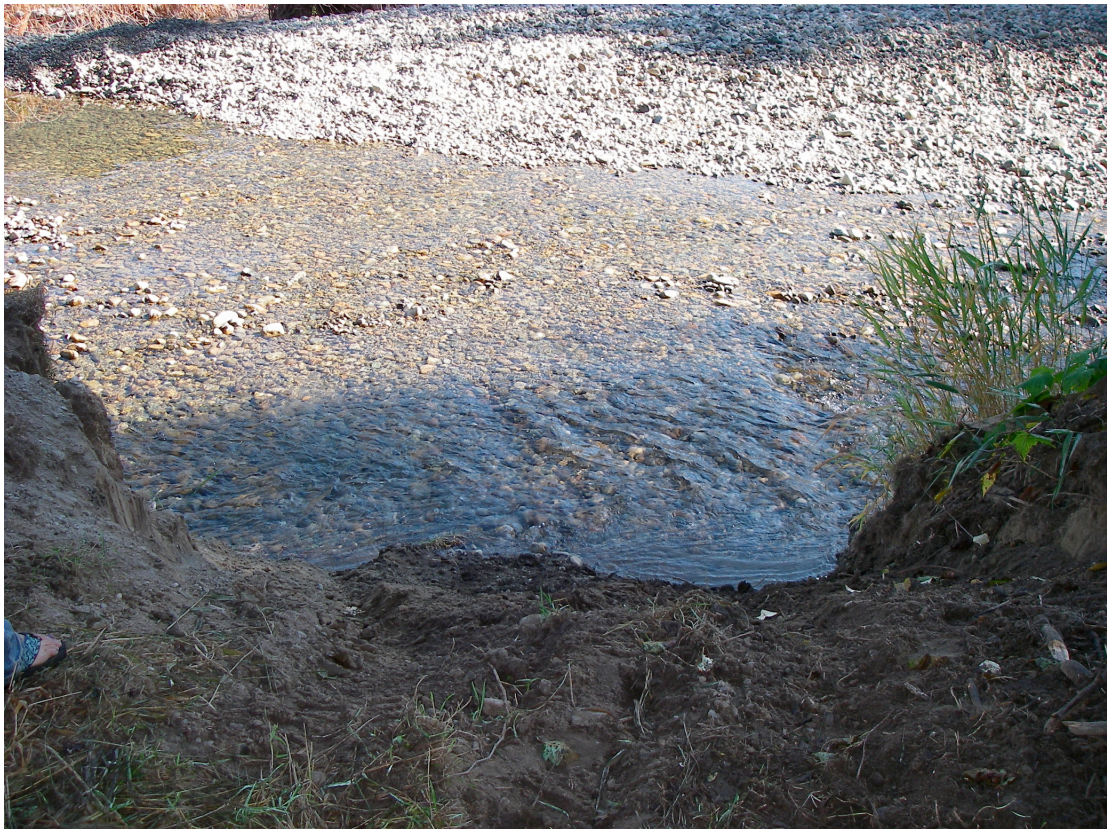
Photo 23. ATV access created at the end of Carney Mill Rd. through the Salmo River.

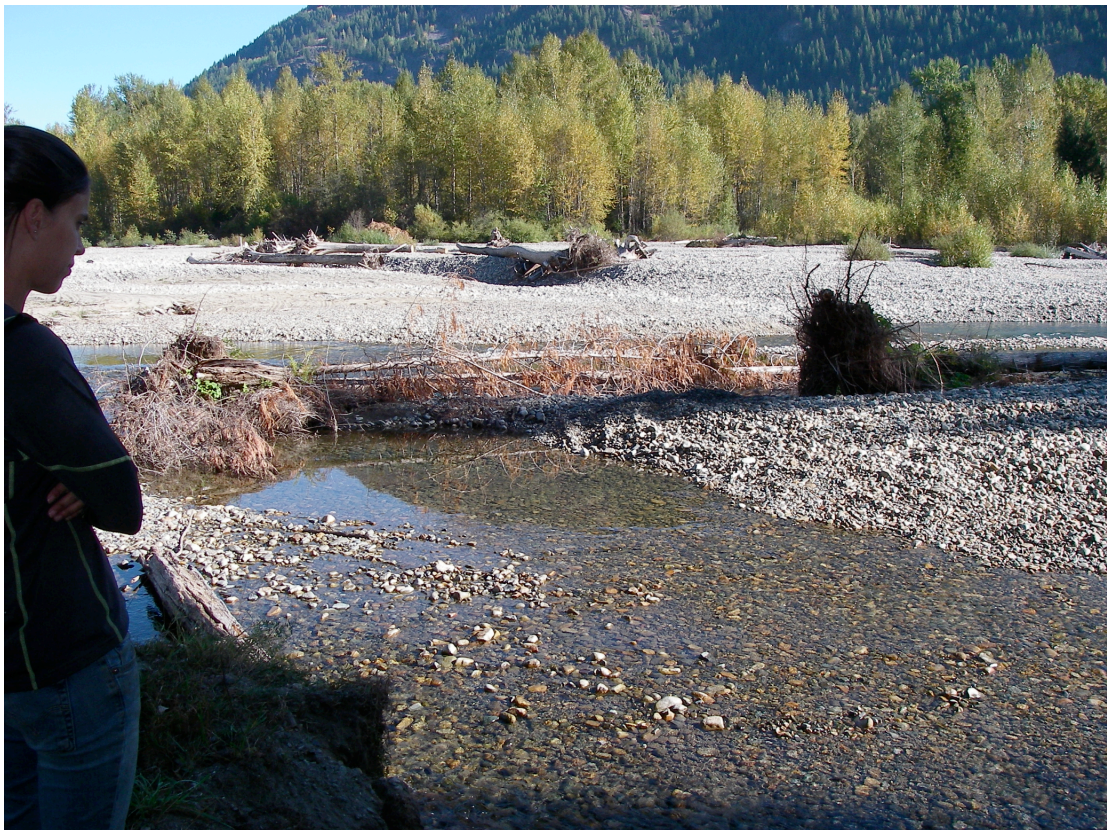
Photo 24. ATV access created at the end of Carney Mill Rd. through the Salmo River.
Note trail over braided area to remove LWD from center braid.
