# Habitat Assessments and Restoration Prescriptions for the "Upper and Lower Car-body Run" of the Salmo River

Salmo Watershed Streamkeepers Society Salmo, B.C.

PSlaney Aquatic Science Ltd. 214 Nelson Street, Coquitlam B.C. V3K 4M4

August, 2004

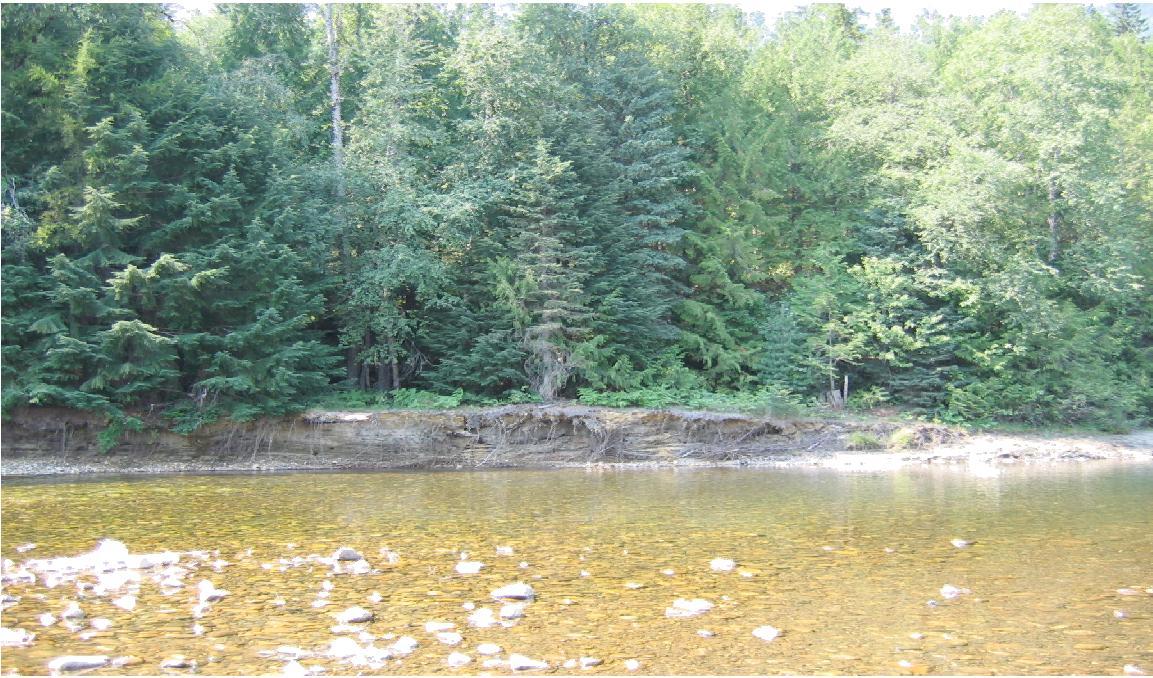
Pool tailout at 120m site: one 2-rootwad triangle on right bank with 3 ramp logs.

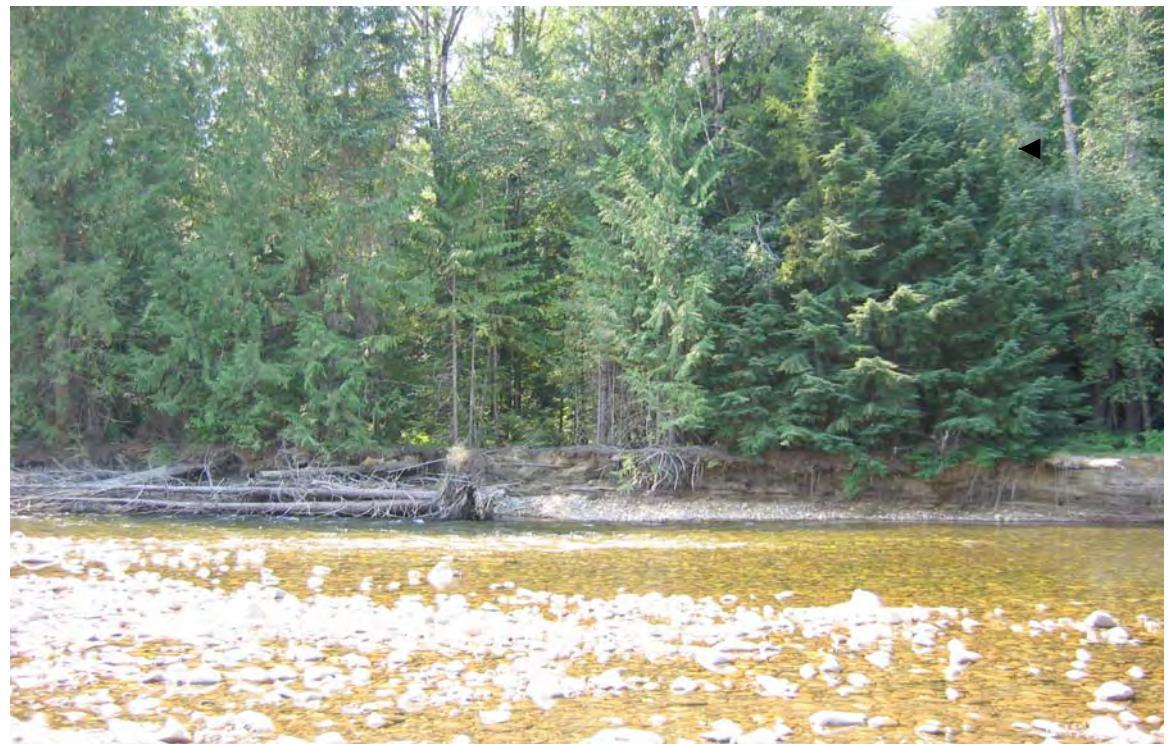
Riffle at 160 m site: 1 triangulated (on top of bank) debris groin with 3 ramp logs.

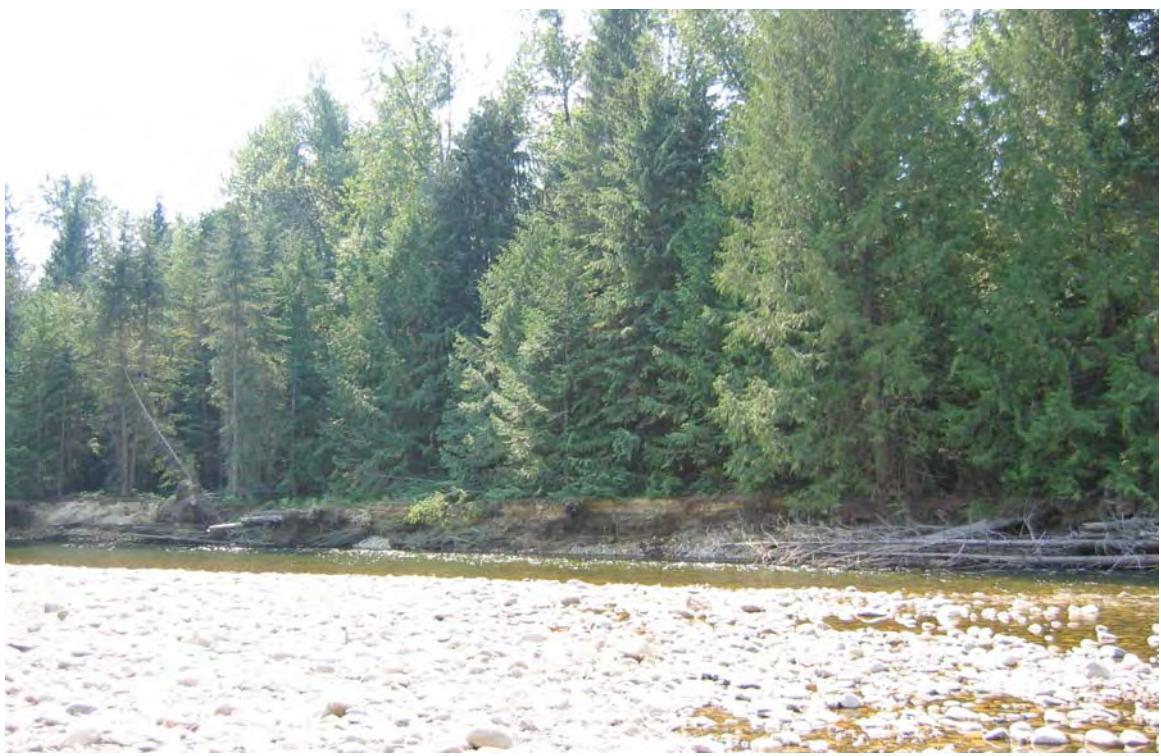
Glide 233 m site: 2 triangulated (on top right bank) debris groin with 3 ramp logs.

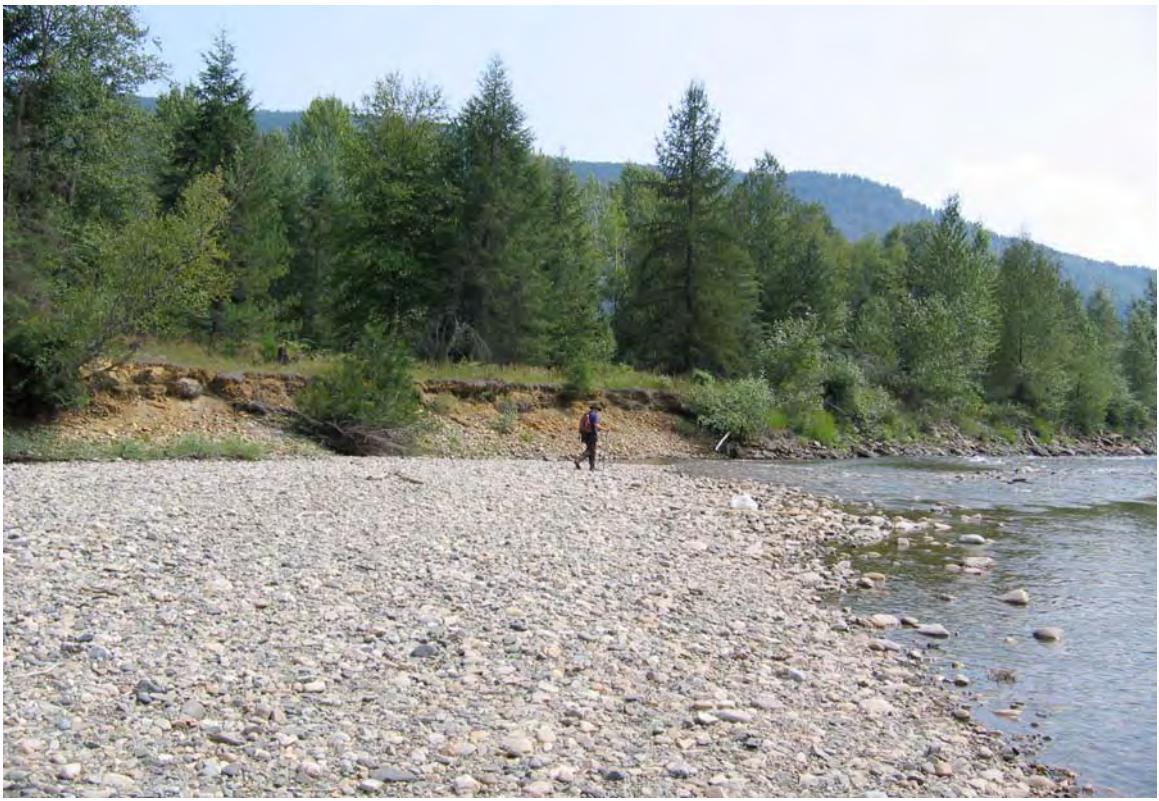
Riffle 357 m site: 1 triangulated debris groin (on top of left bank) with 3 ramp logs

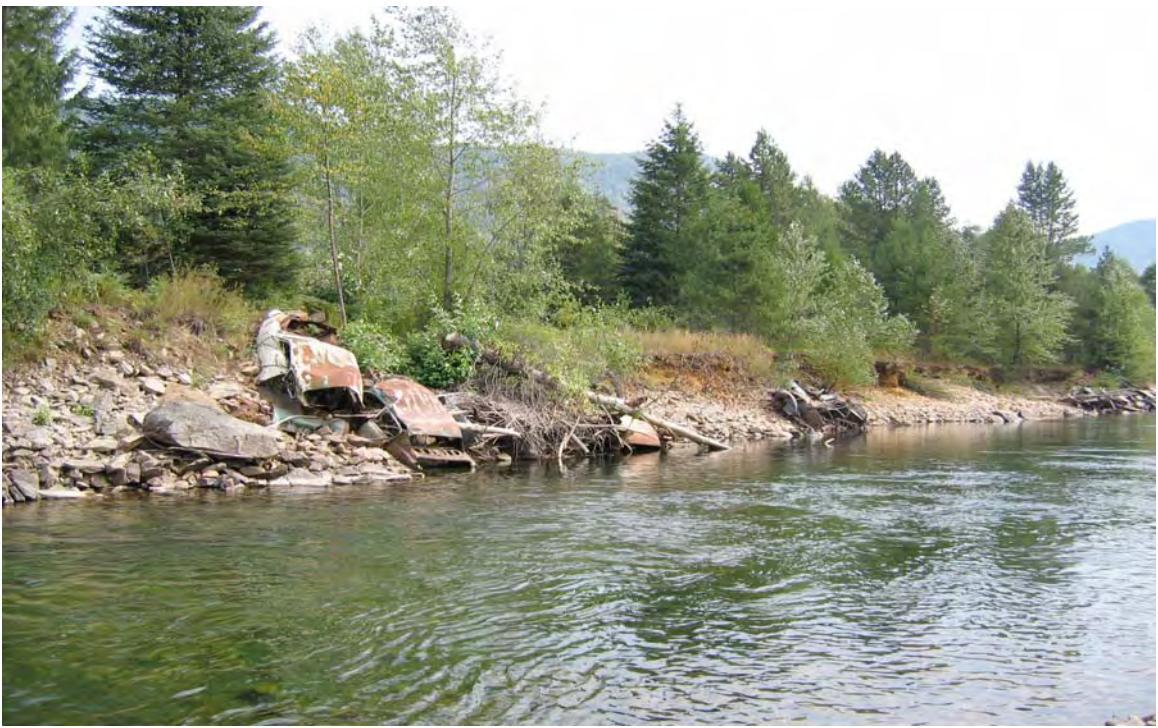
Run (car body) 395 m site: One 2-rootwad triangle on d/s end of rip-rap with no ramp logs: remove old car bodies except for wood-filled one under natural log.

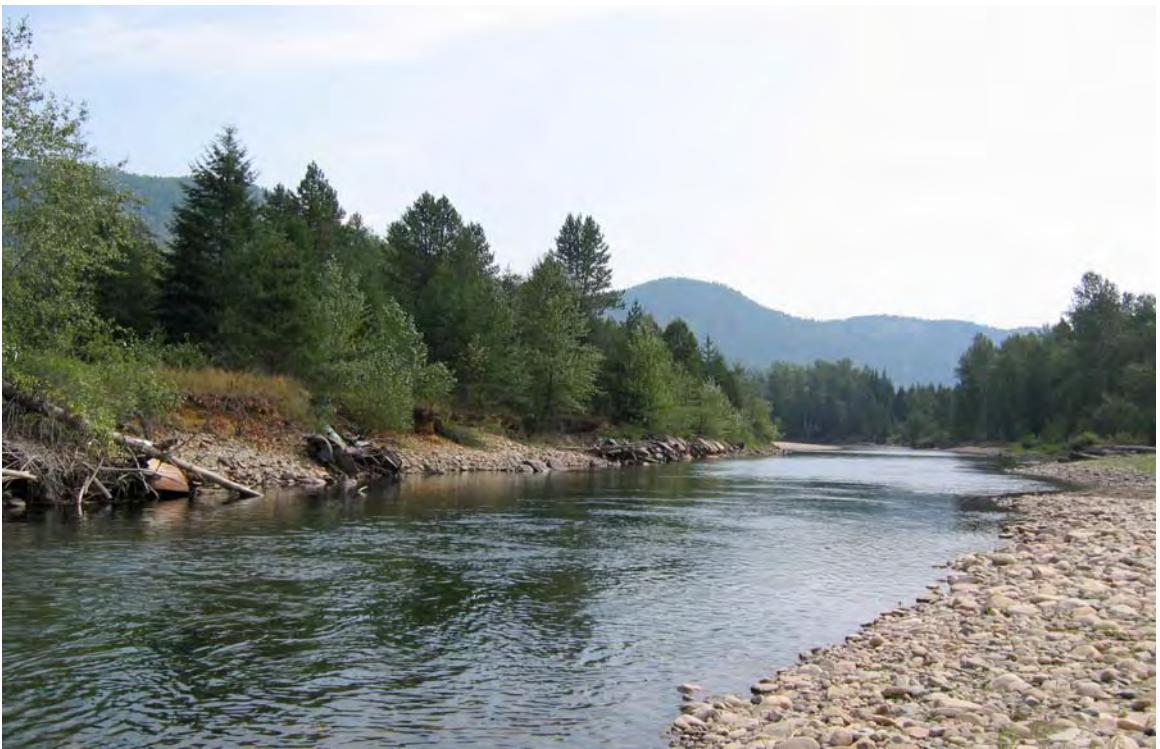
Pool (car body) at 414 m site on left bank: upper section; two 3-rootwad triangles with 3 ramp logs ramped up on rear log into bank; place 3 whole trees behind triangle plus rip-rap base of eroding bank and geotextile (remove car bodies);

7	514 m	<b>119 m (car-body) Pool:</b> <u>Upper section</u> : two 3-rootwad triangles with 3 ramp logs: <i>preload</i> <u>plus</u> install 3 parallel single whole trees and rip-rap at bank base to prevent back-eddy erosion of bank

<u>plus</u> place geo-textile over silty bank: support by rebar on bank and rocks at bank toe <u>Lower section</u>: two 2-rootwad triangles on left bank with 2 ramp logs

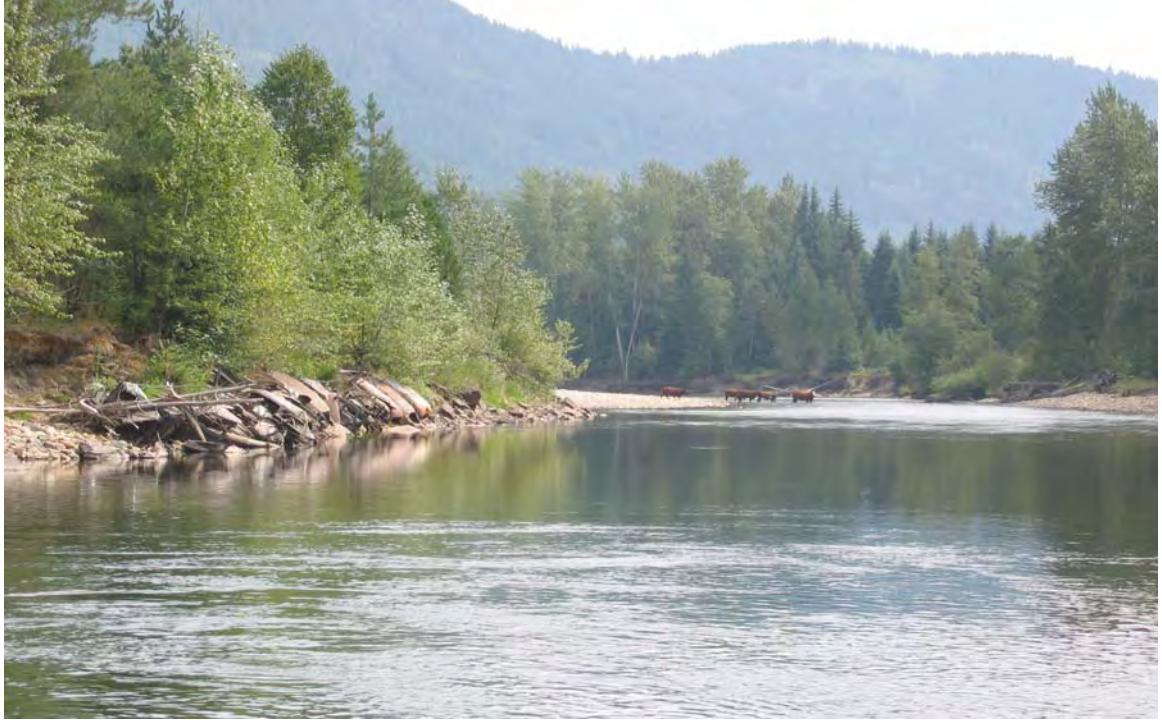
Pool (car body) at 414 m site at lower section; two 2-rootwad triangles on car bodies (after removal) on left bank slope with 2 ramp logs.

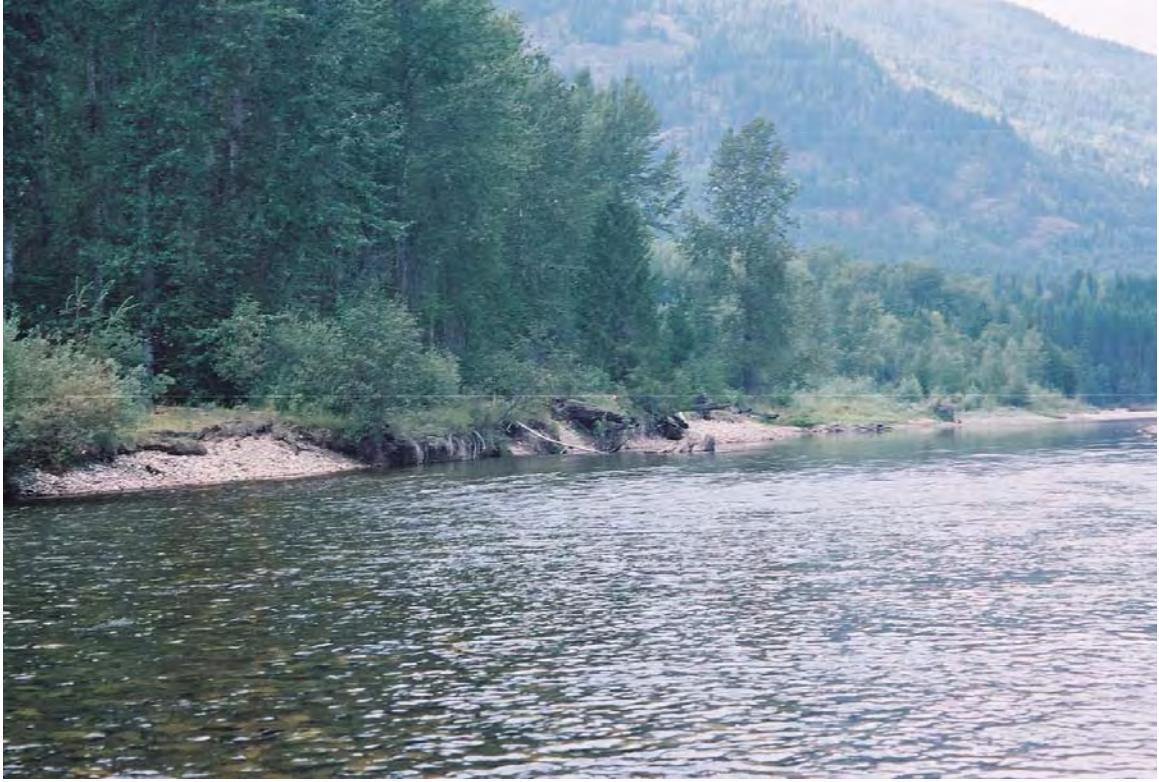
Riffle 744 m site (opposite cattle): two 2-rootwad triangular right bank LWD structures: upper site with 2 ramp logs.

- 8 681 m 167 m Glide-flat: Nil: wide flat water habitat unit
- 9 744 m **63 m Riffle:** two 2-rootwad triangles on right bank upper site: 2 ramp logs: lower. site: 3 ramp logs plus *preload*

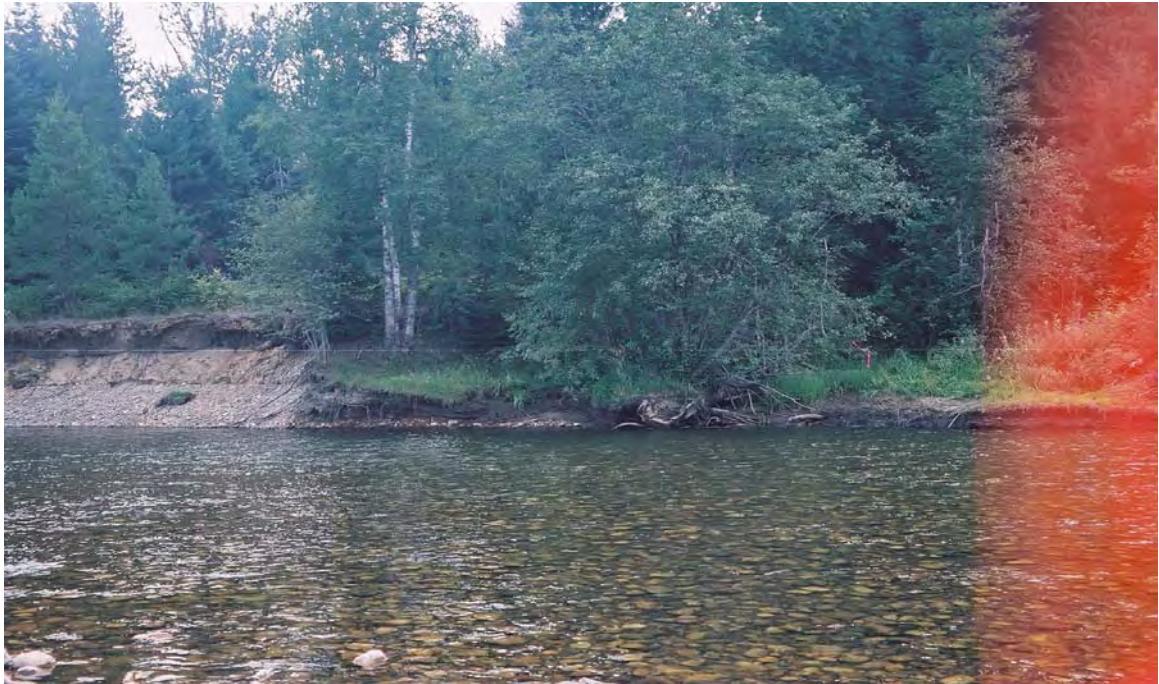
Riffle 744 m site (opposite cattle): two 2-rootwad triangular right bank LWD structures: lower site with 3 ramp logs (tie into large extending log)

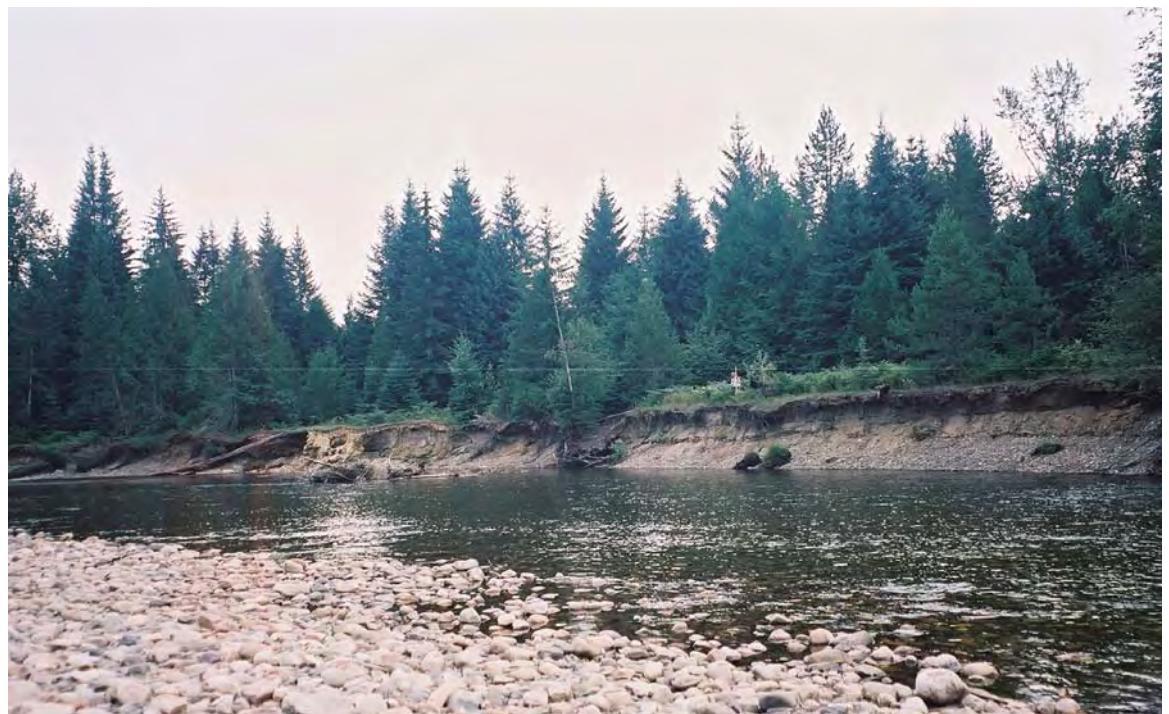
Riffle 838 high eroding right bank site(upper):1 triangulated 2-rootwad debris groins secured onto bank top, with 3 ramp logs from river to protruding tri-apex. Glide 838 m high eroding right bank site: 1 triangulated 2-rootwad debris groin secured onto bank top, with three ramp logs from river to protruding tri-apex.

- 10 838 m 94 m Glide-flat run: 1 triangulated debris groin with 3 ramp logs: right bank: preload
- 11 919 m 81 m Riffle: 3 triangulated debris groins with 3 ramp logs: right bank: *preload*

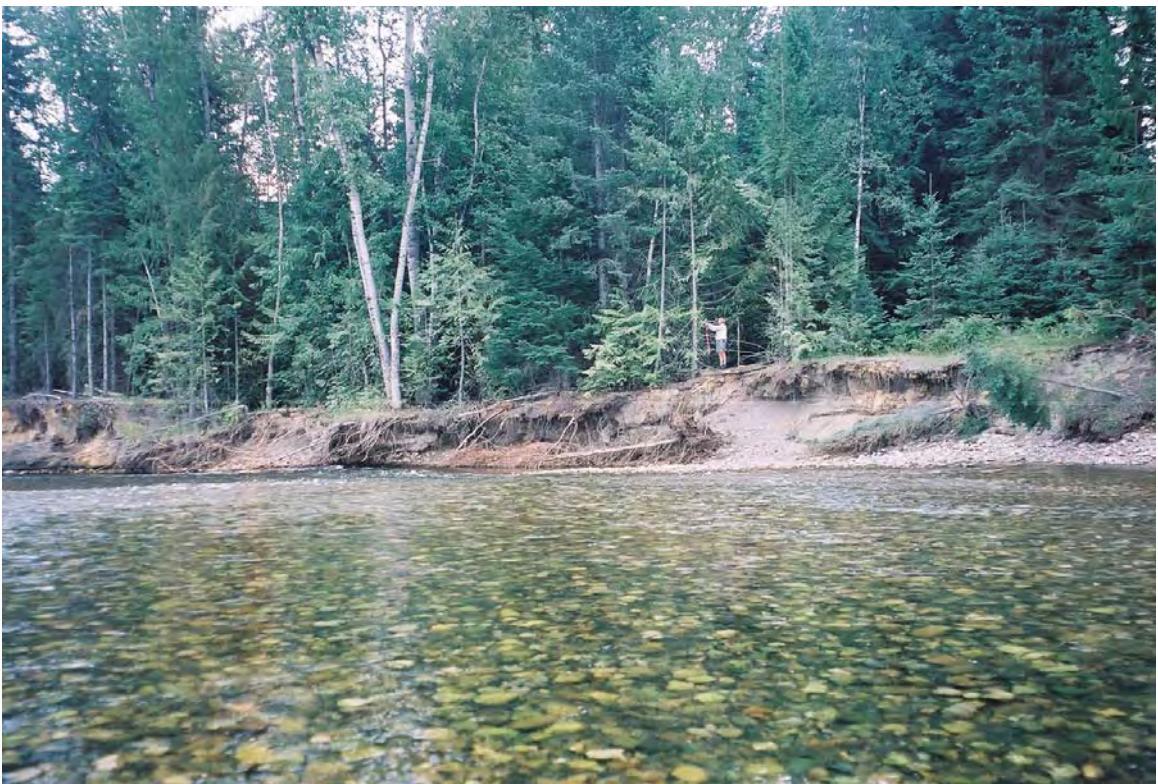
Riffle 919 m right eroding bank site: 3 triangulated 2-rootwad debris groins secured onto bank top, with three ramp logs from river to protruding tri-apex

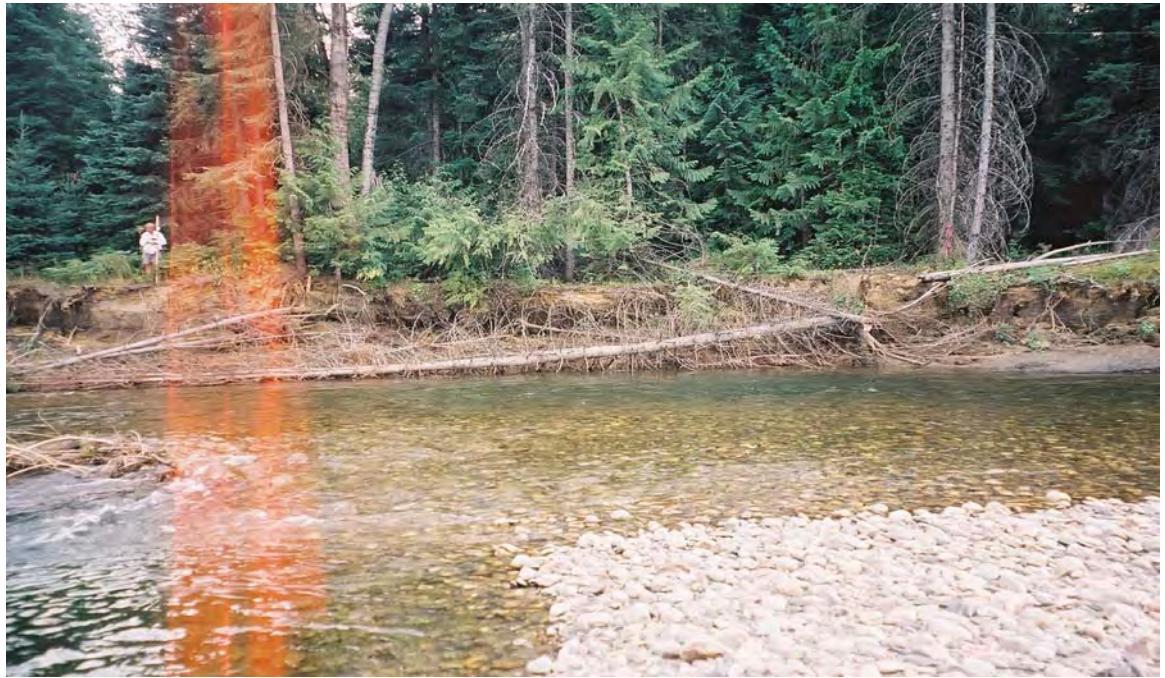
Glide 970 m eroding right bank site: 1 triangulated 2-rootwad debris groins secured onto bank top, with three ramp logs from river to protruding tri-apex, with 2 parallel rootwads ballasted against bank.

- 12 970 m **51 m Glide:** 1 triangulated debris groin with 3 ramp logs: right bank: *preload* Plus fill with 2 lateral parallel rootwads at bank to u/s groin

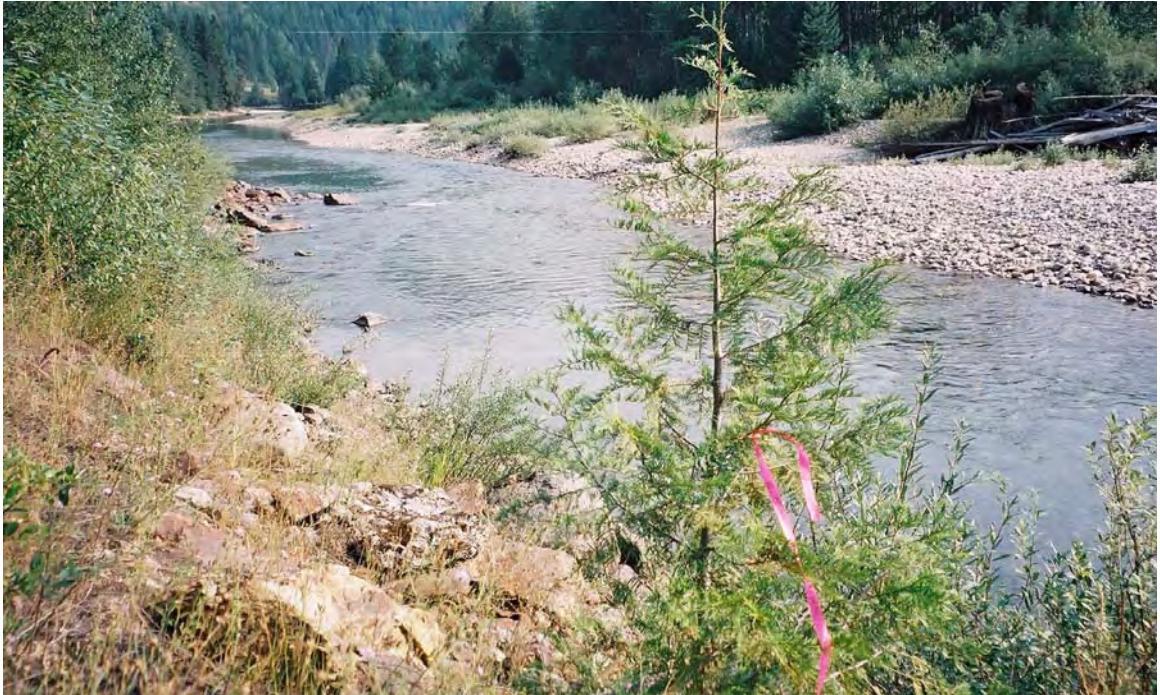
1262 Riffle-run 86 m site on left dyked bank (flagged): one 2-rootwad triangle with 2 ramp logs, plus 1490 Glide-flat: three 2-rootwad triangles with 2 ramp logs; (note:1176 glide with two parallel rootwads is located 20 m upstream of photo)

- 17 1262 m 86 m Riffle-run: one 2-rootwad triangle on left bank with two ramp logs
- 18 1490 m 128 m Glide-flat run: three 2-rootwad triangles on left bank with two ramp logs

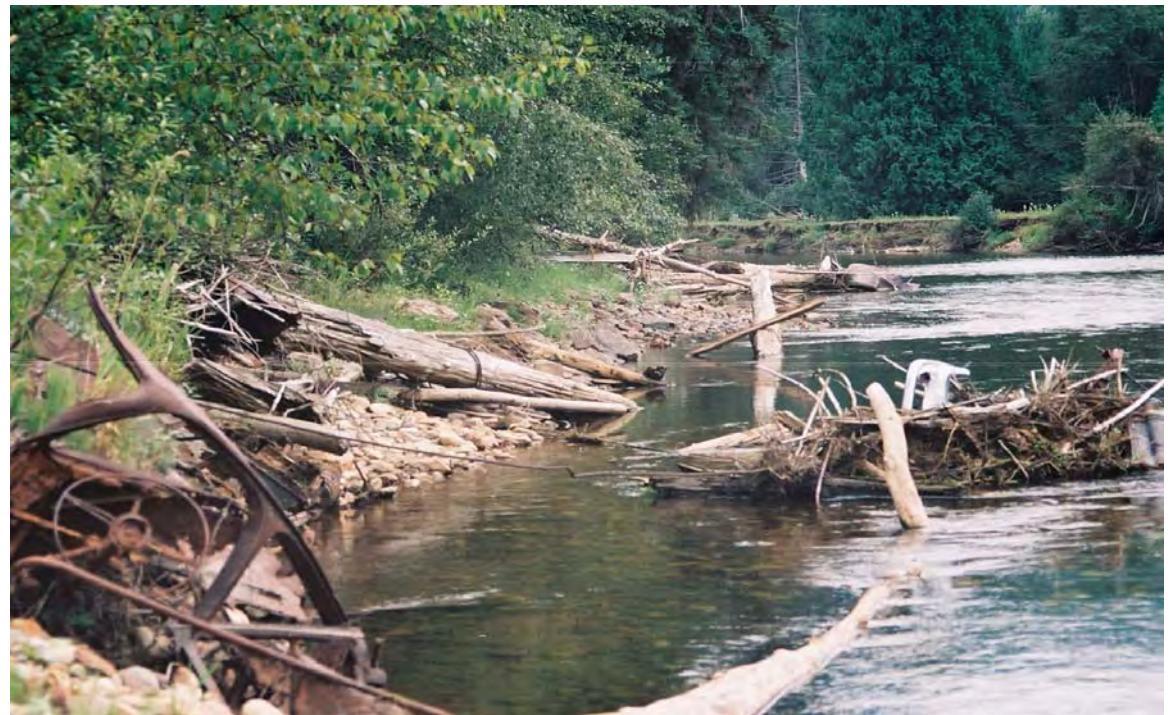
1745 Riffle-glide ("lower car run") on left bank: two 2-rootwad triangles with 2 ramp logs plus one 2-rootwad triangle with no ramp logs added to existing natural LWD structure in background of photo (remove remaining car bodies).

- 20 1745 m **124 m Riffle-glide:** two 2-rootwad triangles on left bank with two ramp logs <u>Plus</u> add one 2 rootwad triangle on existing d/s left bank LWD site

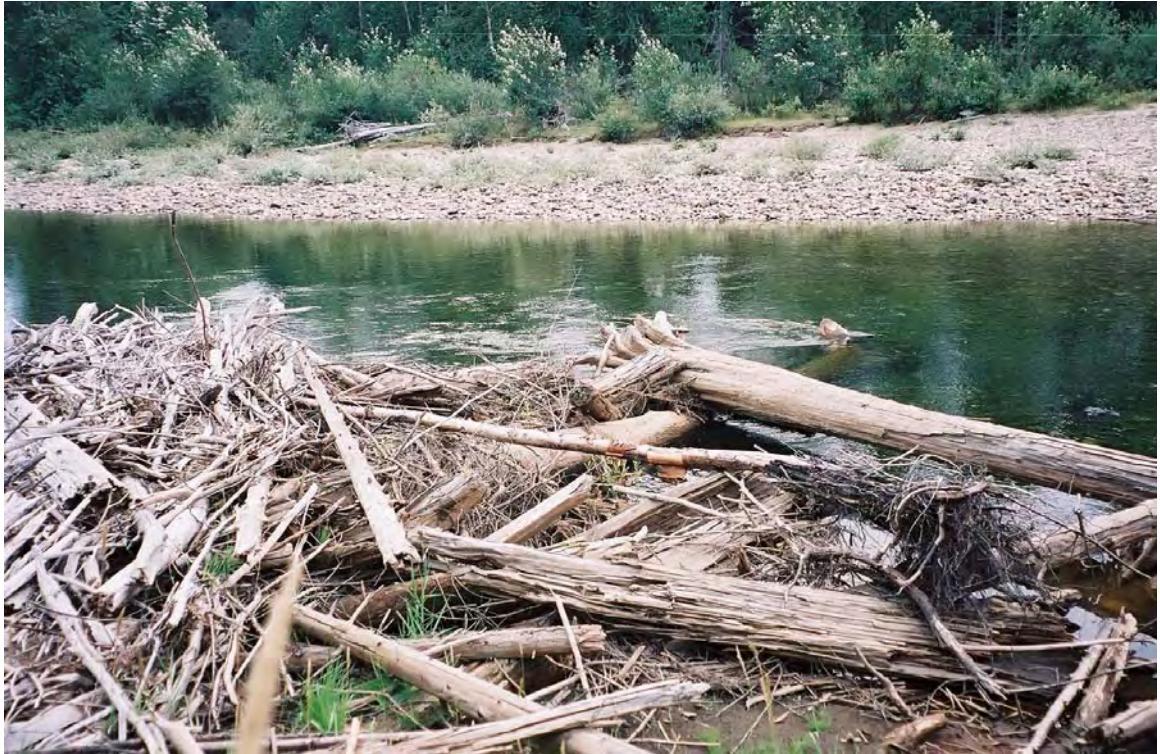
Natural *template* triangle LWD structure in the lower Salmo River with collection of driftwood, armouring the left bank of the lower car-body run.
