# Habitat Assessments and Restoration Prescriptions for the "Upper and Lower Car-body Run" of the Salmo River

Salmo Watershed Streamkeepers Society Salmo, B.C.

PSlaney Aquatic Science Ltd. 214 Nelson Street, Coquitlam B.C. V3K 4M4

August, 2004

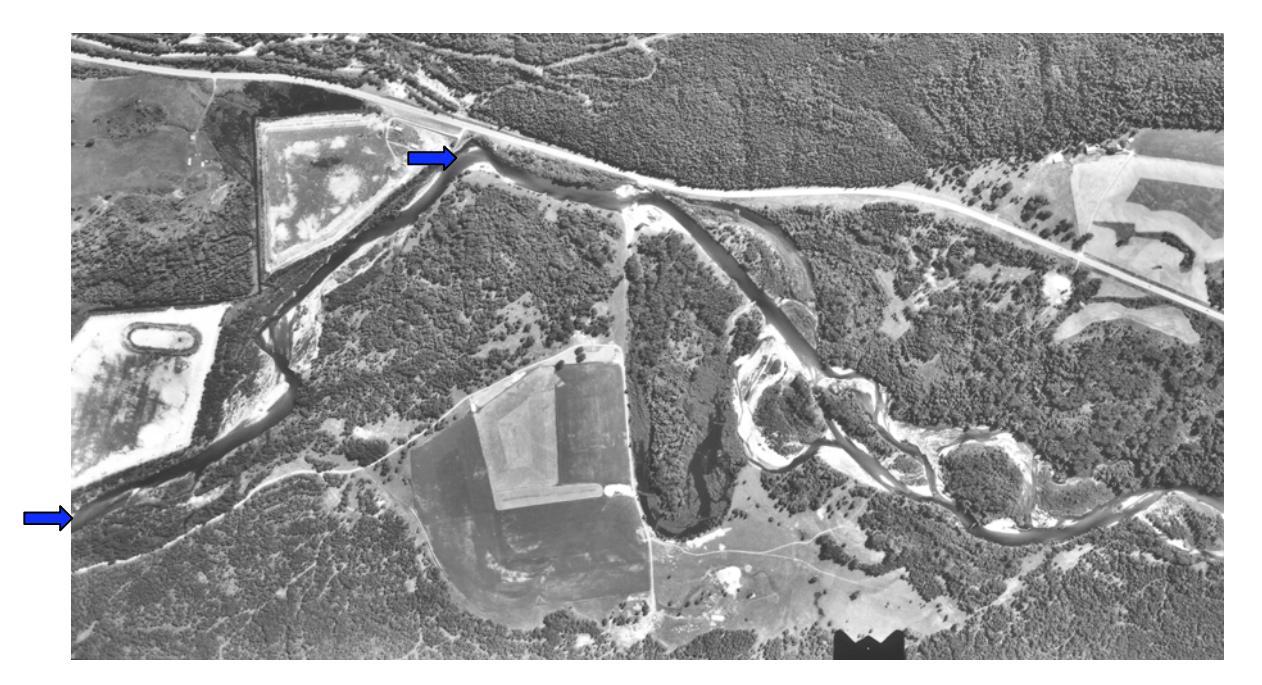
**Figure 1.** Airphoto of the lower Reach of the Salmo River, with arrows indicating the surveyed river segment (scale  $1 \text{ cm} \sim 170 \text{ m}$ ; flow direction is north to south or from the left to right of the air photo; the first pool -at arrow - not in the photo). The surveyed reach is located 10-11 km south of the town of Salmo (located 40 km west of Nelson and Trail.

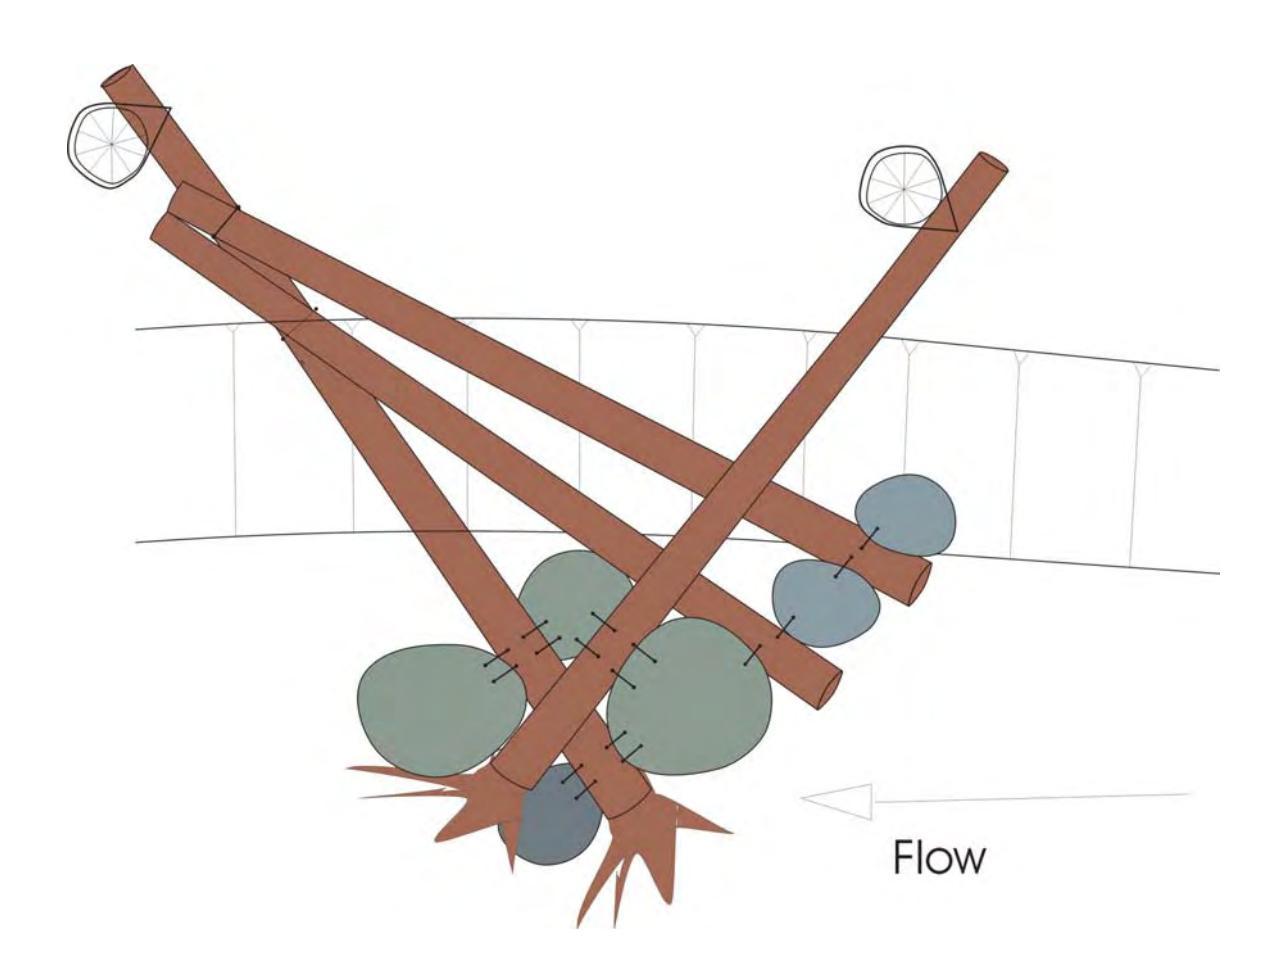
**Figure 4.** Lateral triangular rootwad ramp-log structure concept designed to trap driftwood, while protecting streambanks.

Conceptual Design Notes Applicable to Salmo River: The 2-3 ramp logs are placed under the upstream rootwad and over the downstream rootwad or log (as in the photo examples from the Seymour River; Figure 6a, 6b). Elevation of the ramp logs is then achieved by reducing the height of the upstream log and increasing the height of the downstream log by varying their placements on the bank slope. The ramp logs are then sloped up towards the bank to collect drift wood and minimize bank erosion; the upper ramp log ends are therefore cable secured to the upper portion of the downstream rootwad

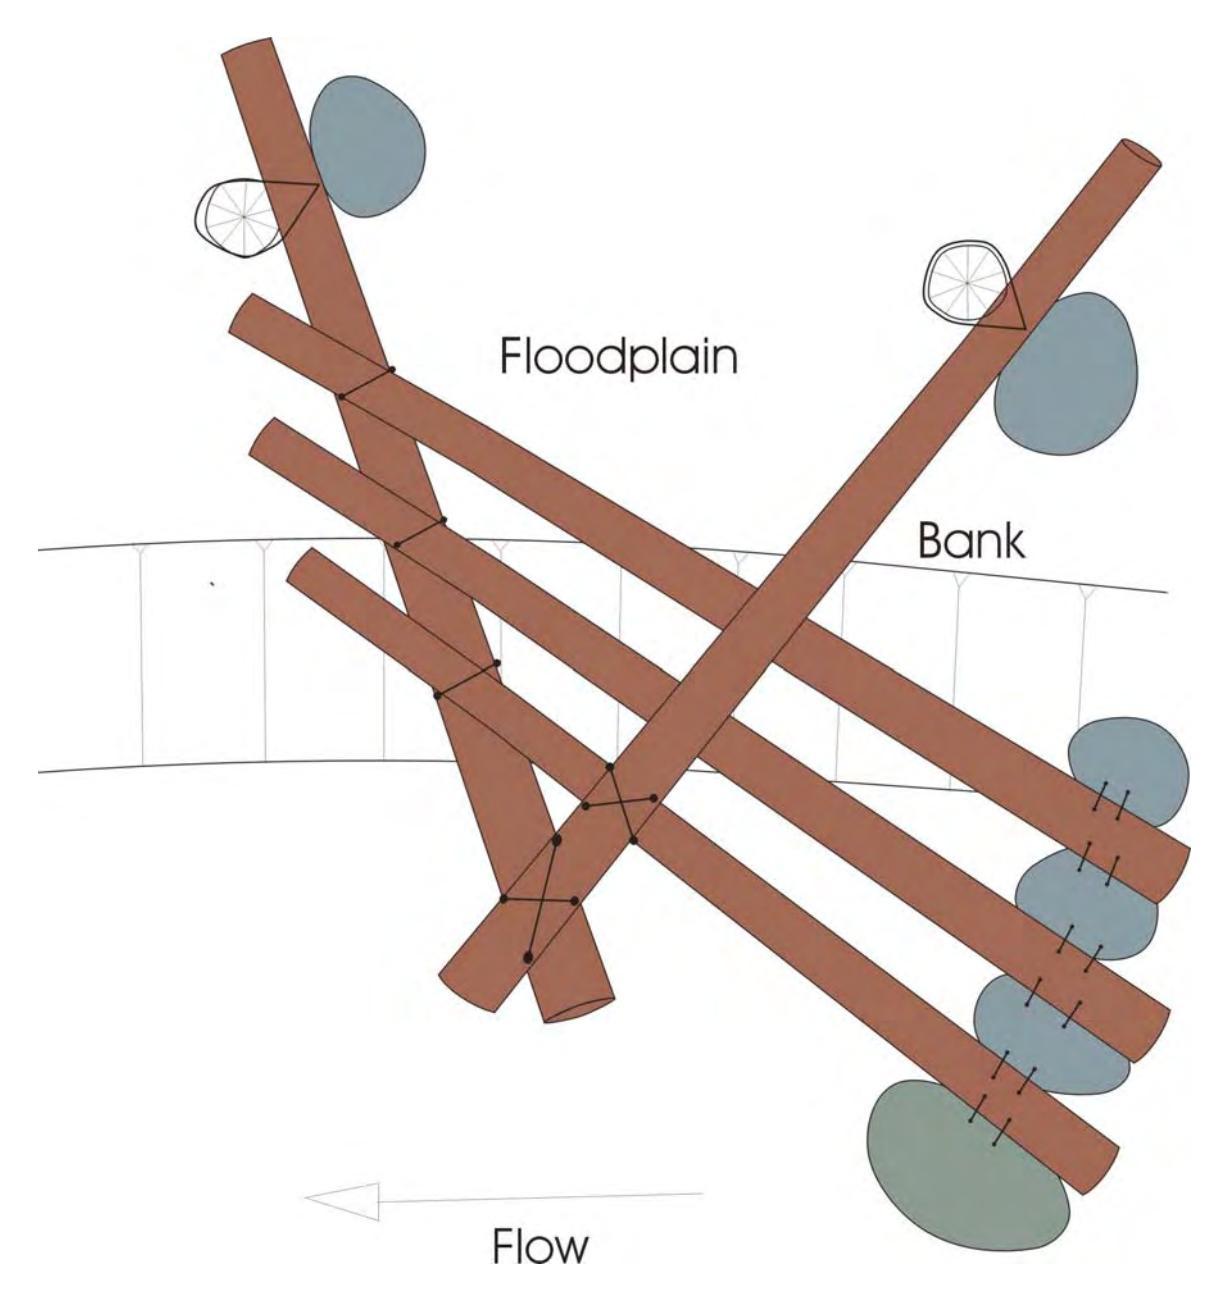
**Figure 5.** Modified triangular debris groin structure for high stream banks, a design concept for shifting the thalweg away from vertical eroding banks.

Conceptual Design Notes Applicable to Salmo River: For the triangulated debris groin, the triangle is placed on the floodplain or bank-bench, with the cabled apex extending over the bank by 4-5 m and the opposite ends secured to tree bases and large boulder ballast (>1  $m^3$  per end). Well-ballasted sloping ramp logs at <45° extend from the river bed to the log apex where they are secured with double-clamped cables. An alternative to the floodplain tree-base/boulder anchors are buried (>2 m depth) log deadheads. Excavation of two trenches in the bank would improve long-term stability of the triangulated support logs.

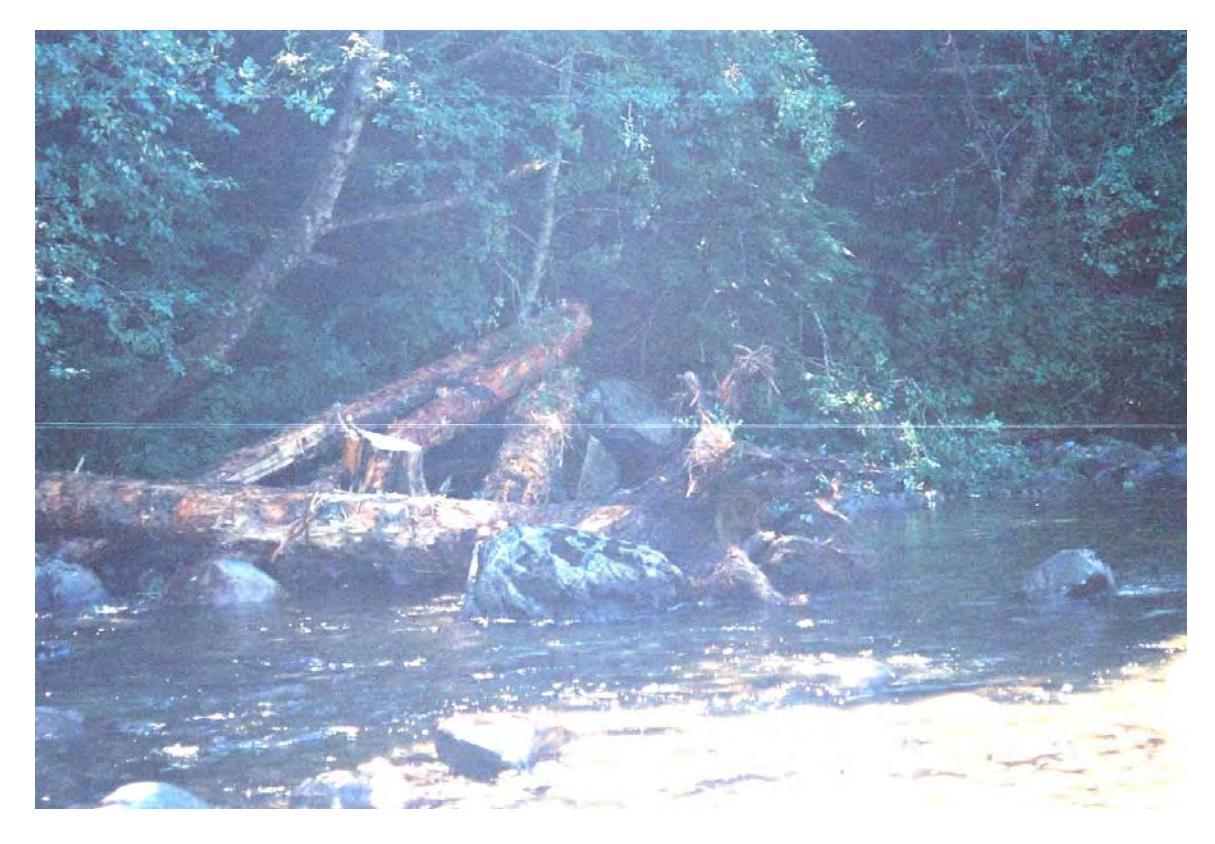
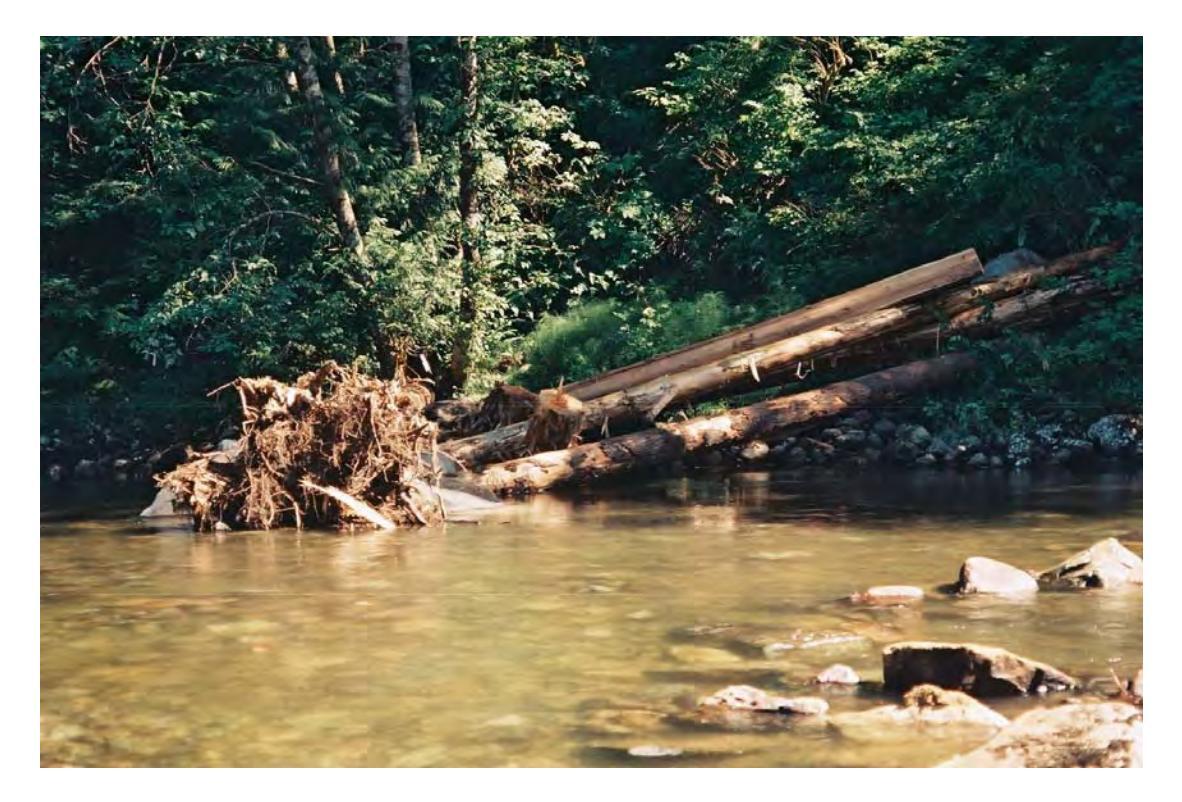
**Figure 6a,b.** Two examples of a rootwad triangle with 3 ramp logs (to collect driftwood), secured under the front rootwad and over the rear triangle log (prior to cabling).

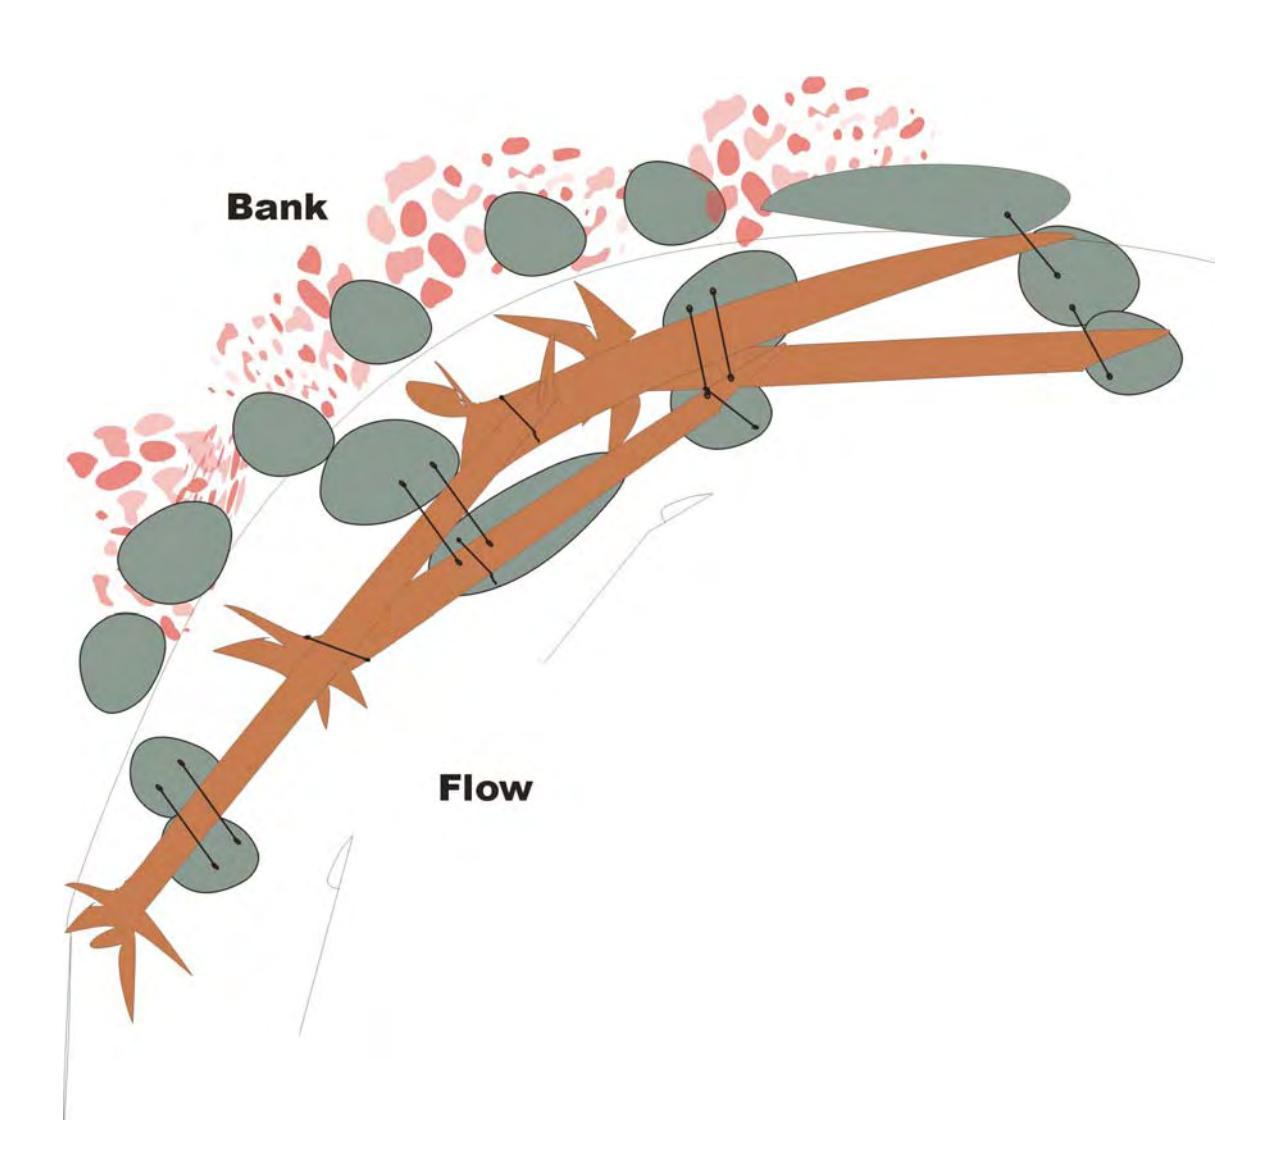
**Figure 7.** Parallel 4-rootwad design concept with 1.5-2 times the ballast weight of triangulated structures to offset drag forces plus buoyancy forces. Double rootwads, as prescribed at two sites in the lower reach of the Salmo River, would exclude 2 of the 4 instream rootwads. Note that rootwads should face downstream (rather than upstream as shown) if paddler navigation is a concern.

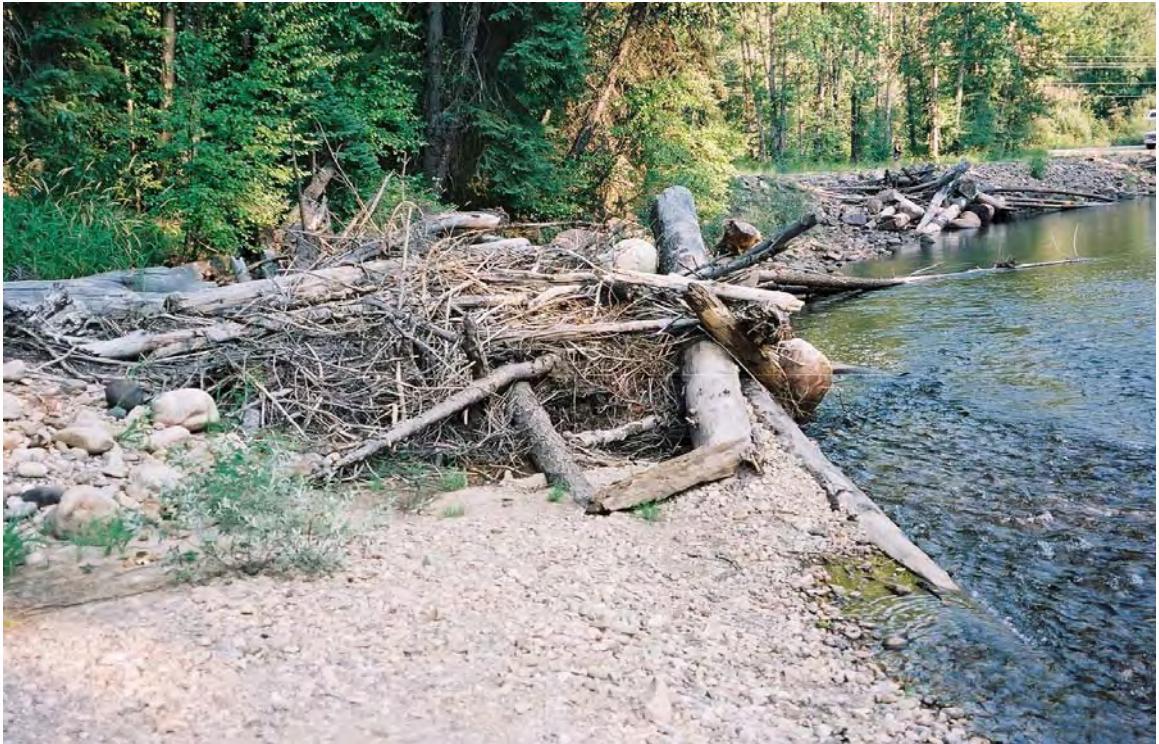
Example of a low profile Debris Groin (1999) at West Kettle River, showing accumulated gravels and woody debris on ramp logs, thus armouring the bank and deflecting the river thalweg.
